# East Badger Mill Creek Watershed Study Report

City of Madison, WI  
May 18, 2023

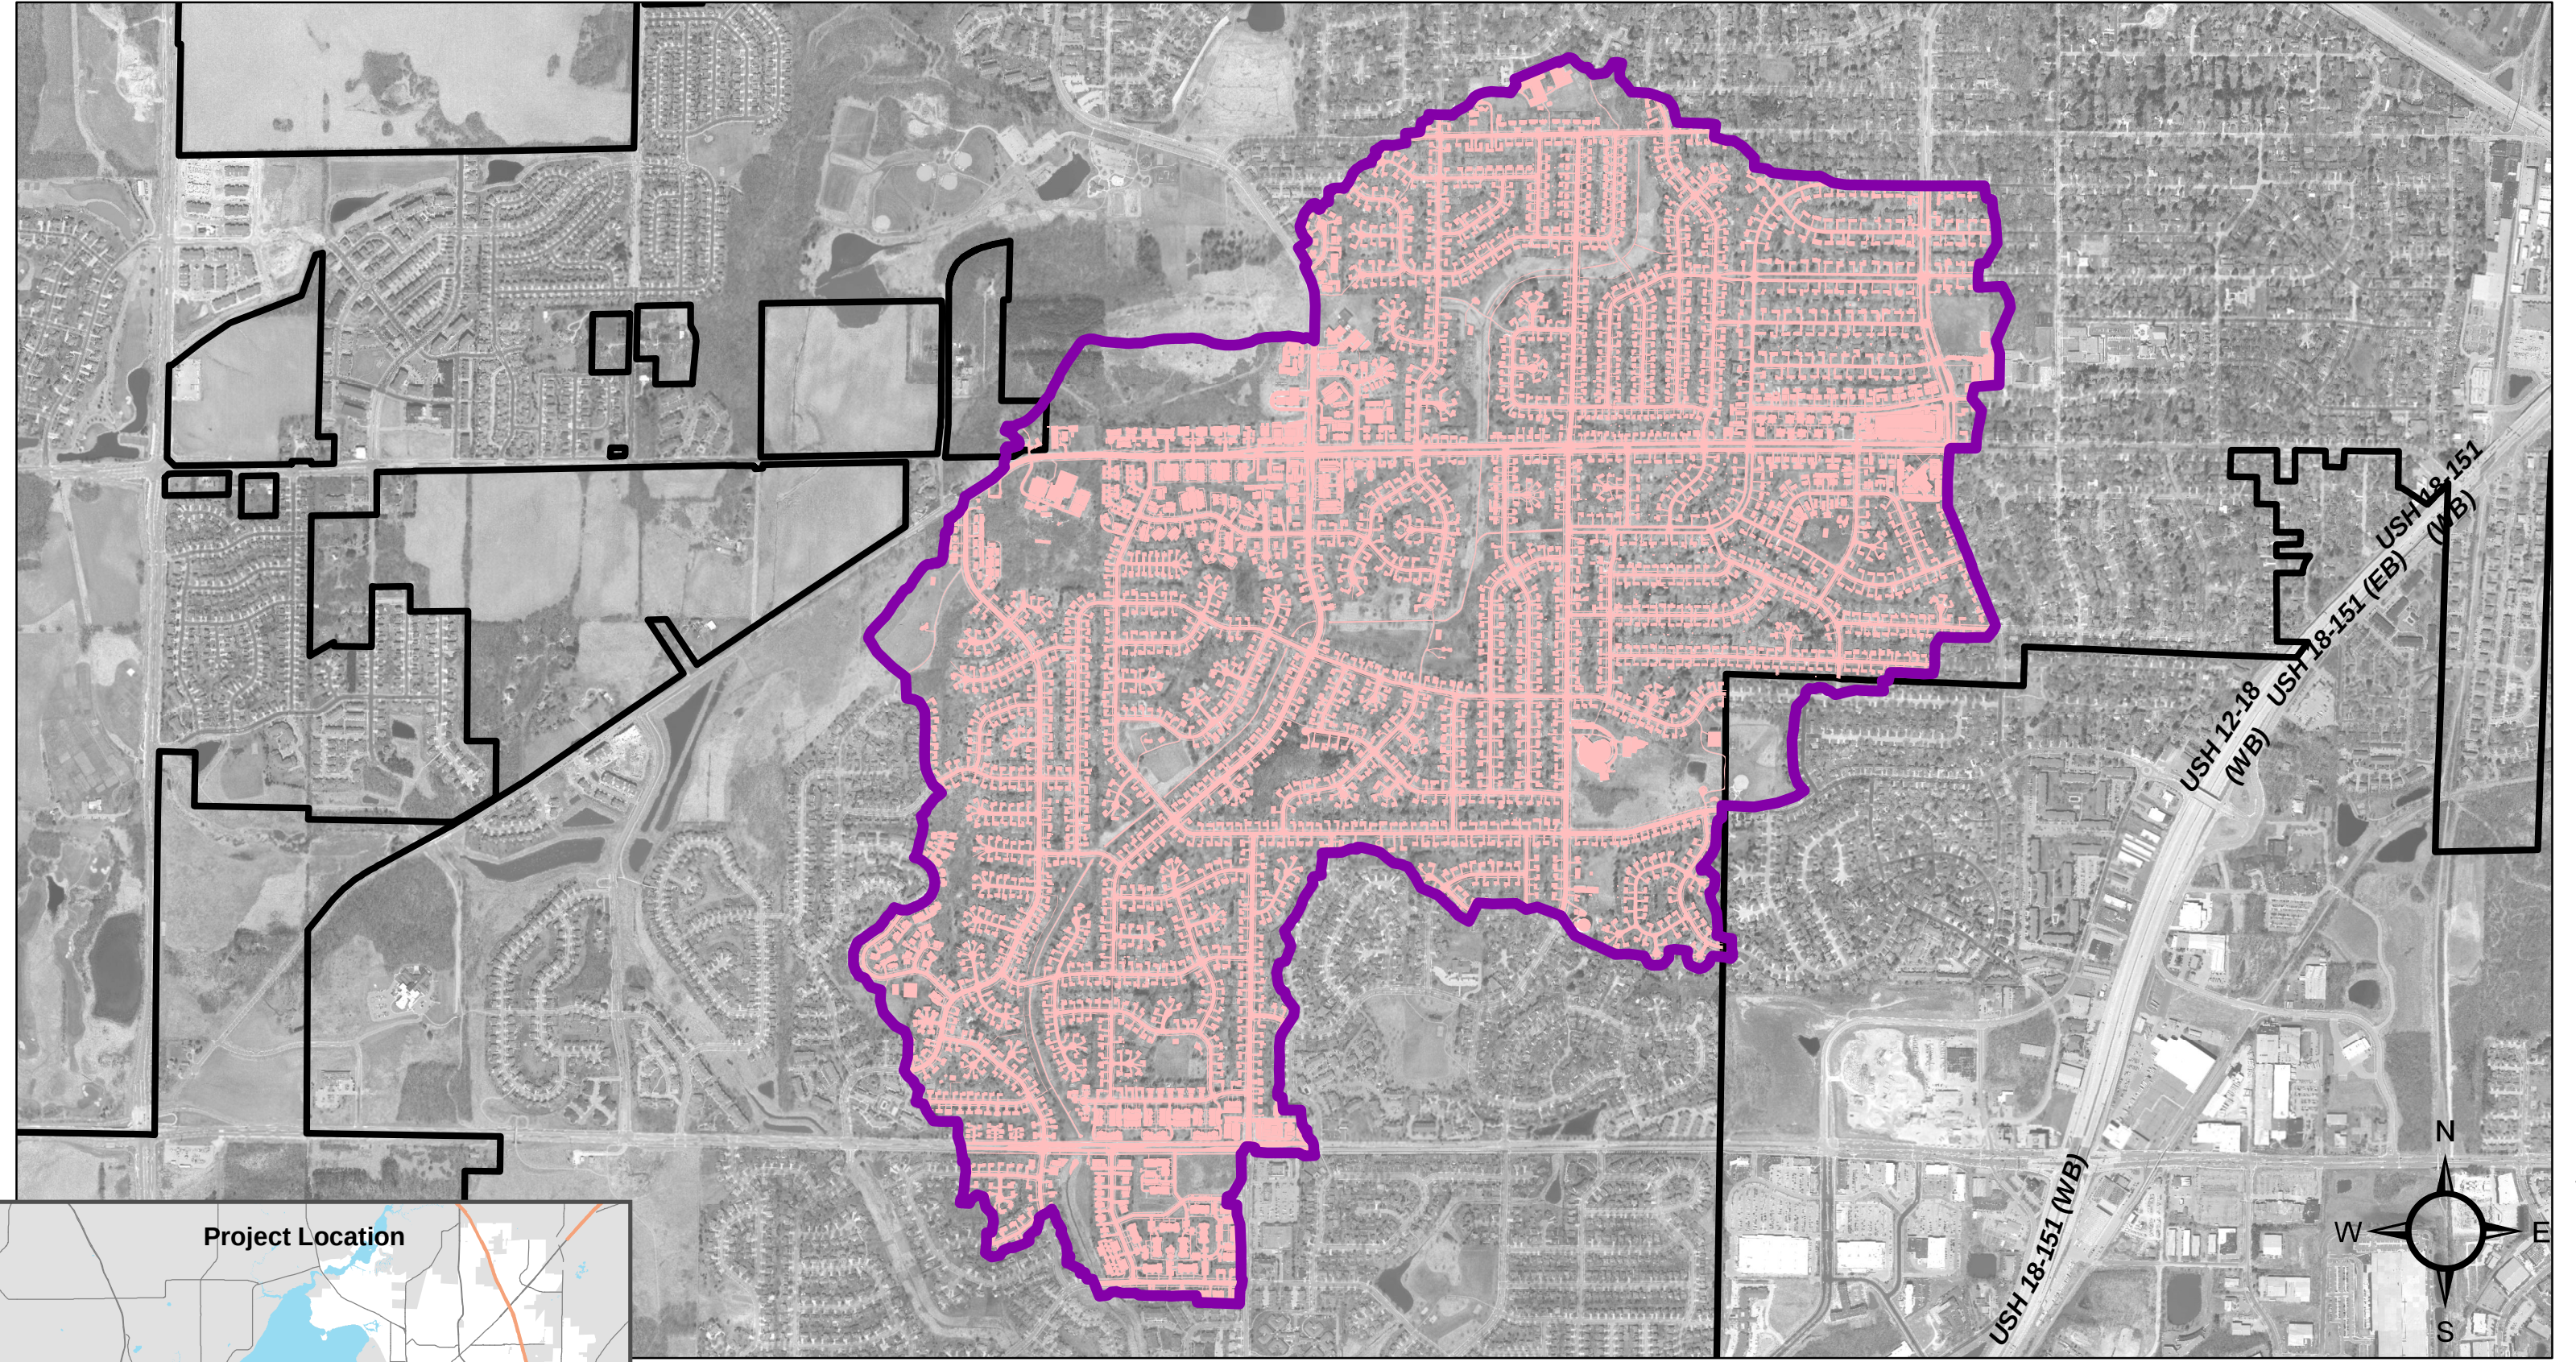
**Figure 2-2**  
**Delineated Impervious Areas**  
**East Badger Mill Creek Watershed**

- Legend**
- Watershed Boundary
  - Municipal Limits
  - Delineated Impervious Areas

areas by land use, and classifying connectedness. **Table 2-3** shows the breakdown of pervious and impervious area in the watershed, which is also displayed in **Figure 2-2**.

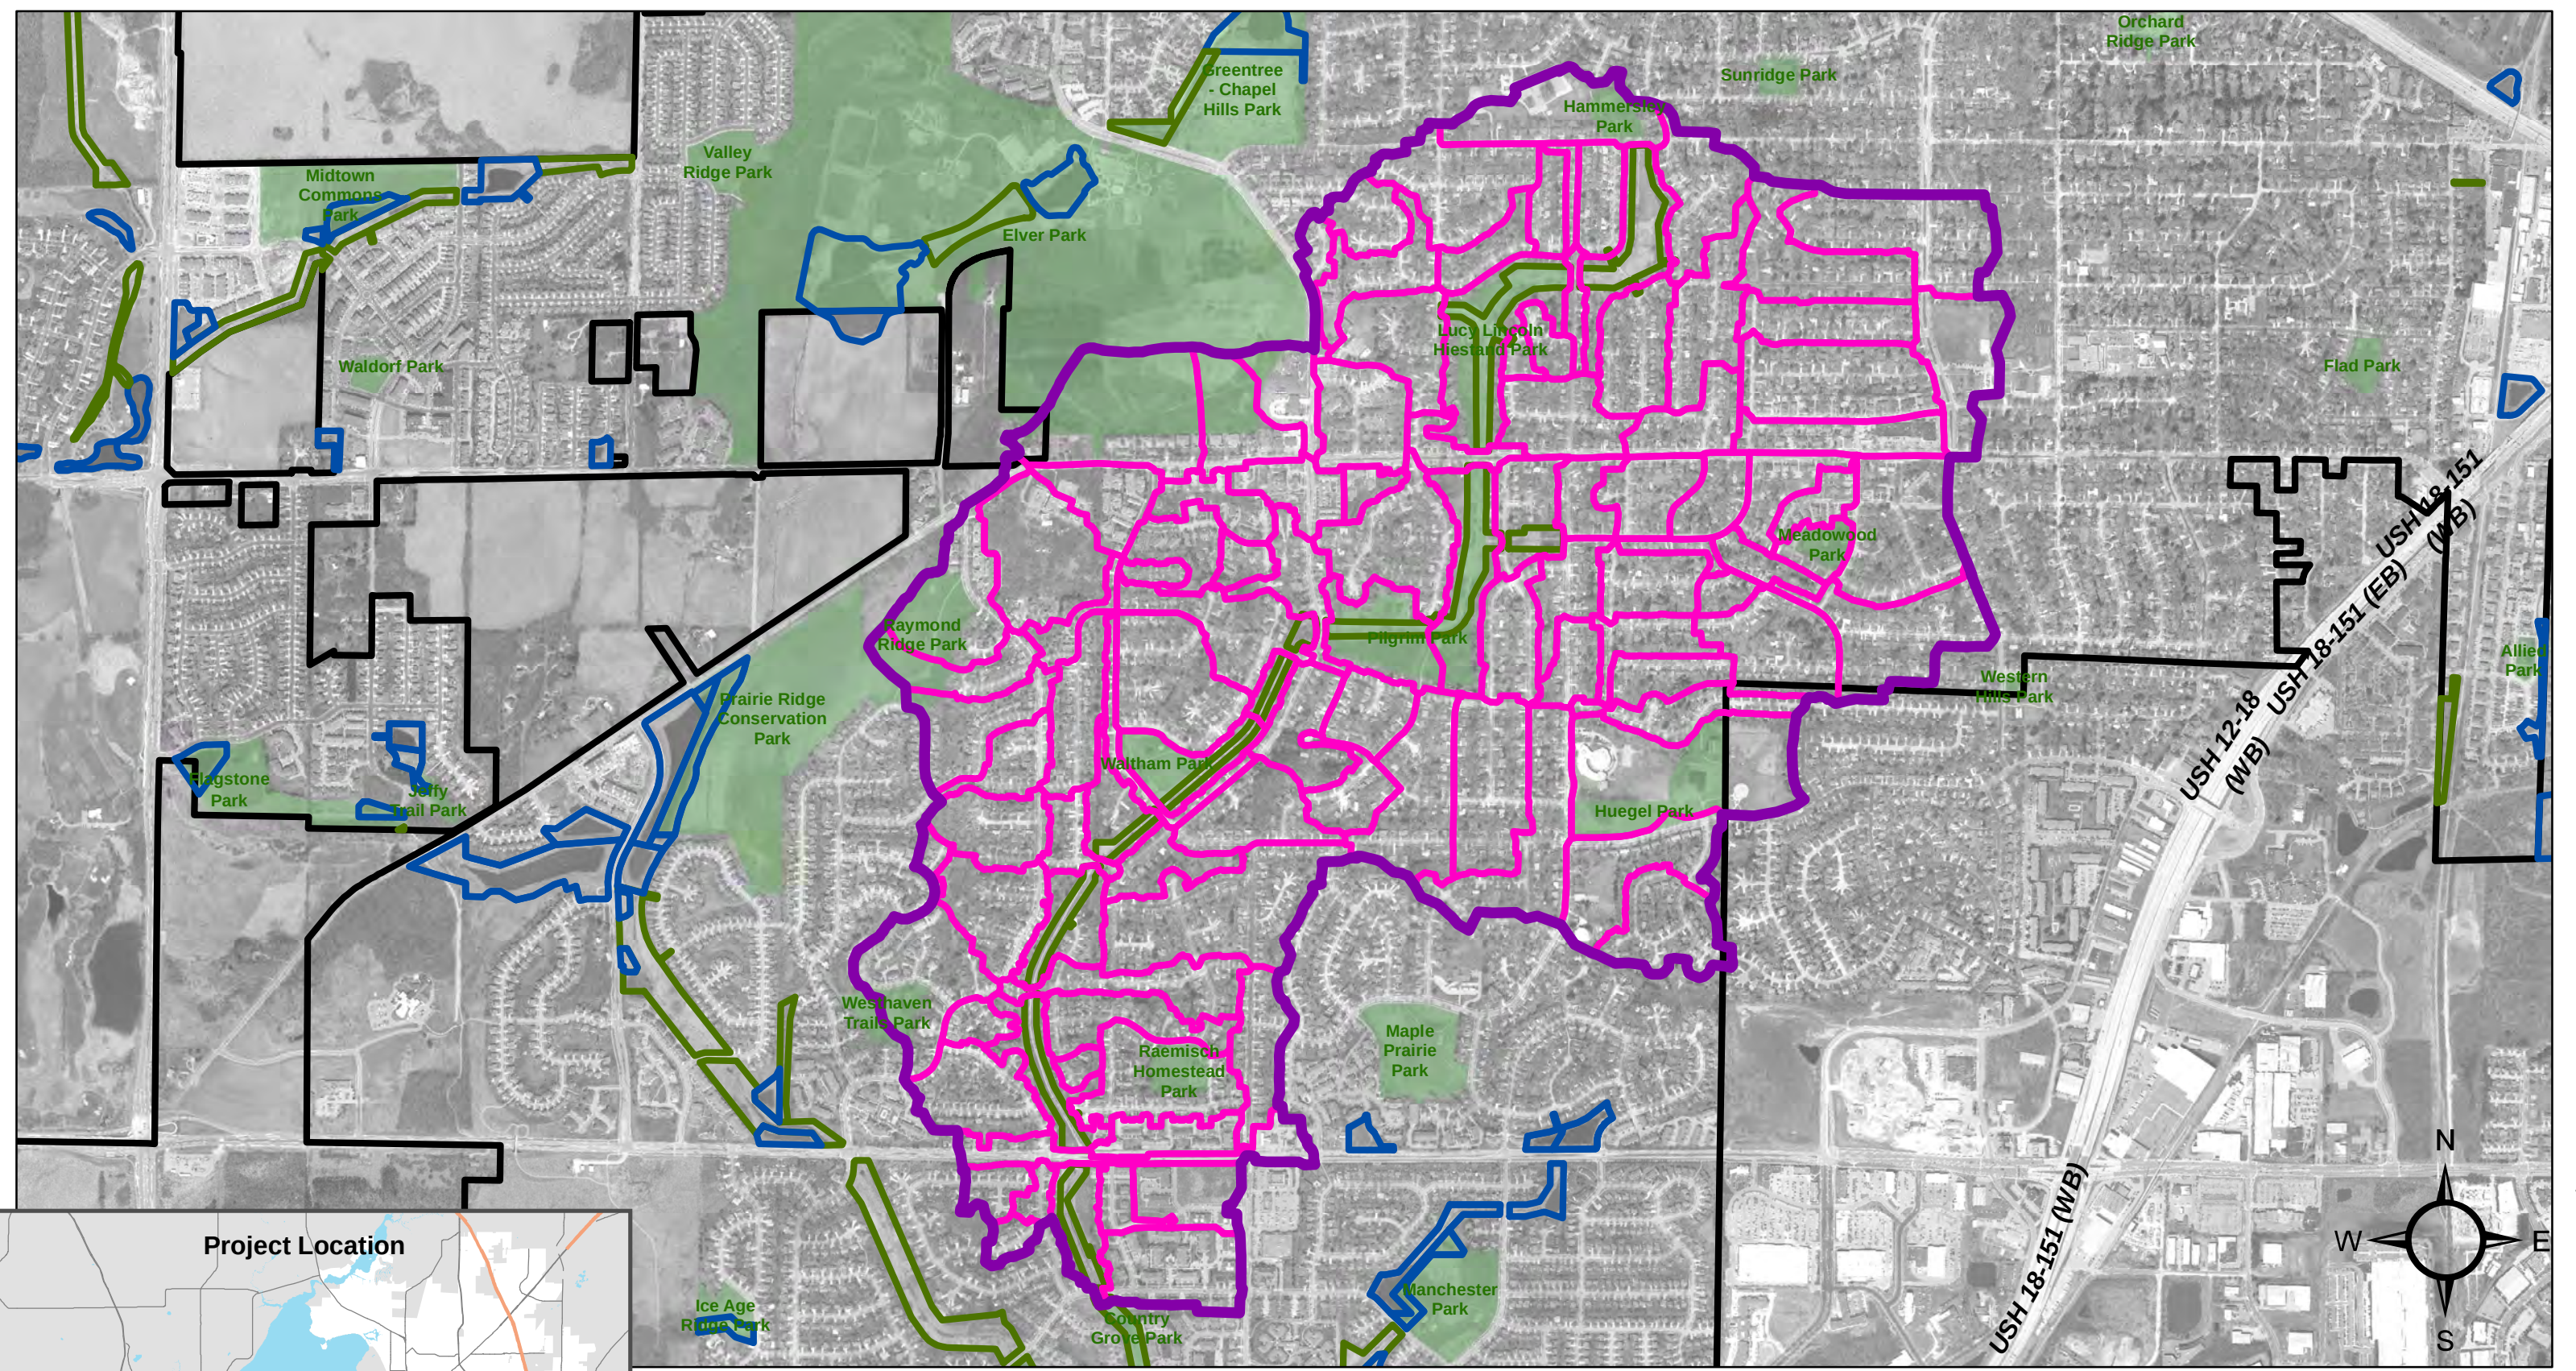
**Figure 4-2**  
**Subcatchments**  
**East Badger Mill Creek Watershed**

- Legend**
- Watershed Boundary
  - Greenway
  - Pond
  - Municipal Limits
  - Park
  - Subwatersheds

The East Badger Mill Creek watershed is divided into 111 subcatchments, which are displayed in **Figure 4-2**. Subcatchments were delineated based on topography, storm sewer maps, drainage features (such as channels and pipes), and land use maps. Each subcatchment is named based on the City's naming convention. Hydrologic input parameters were calculated for each subcatchment, which included quantifying three surface types within each subcatchment based on the impervious area layer. The subcatchment surfaces are defined as:

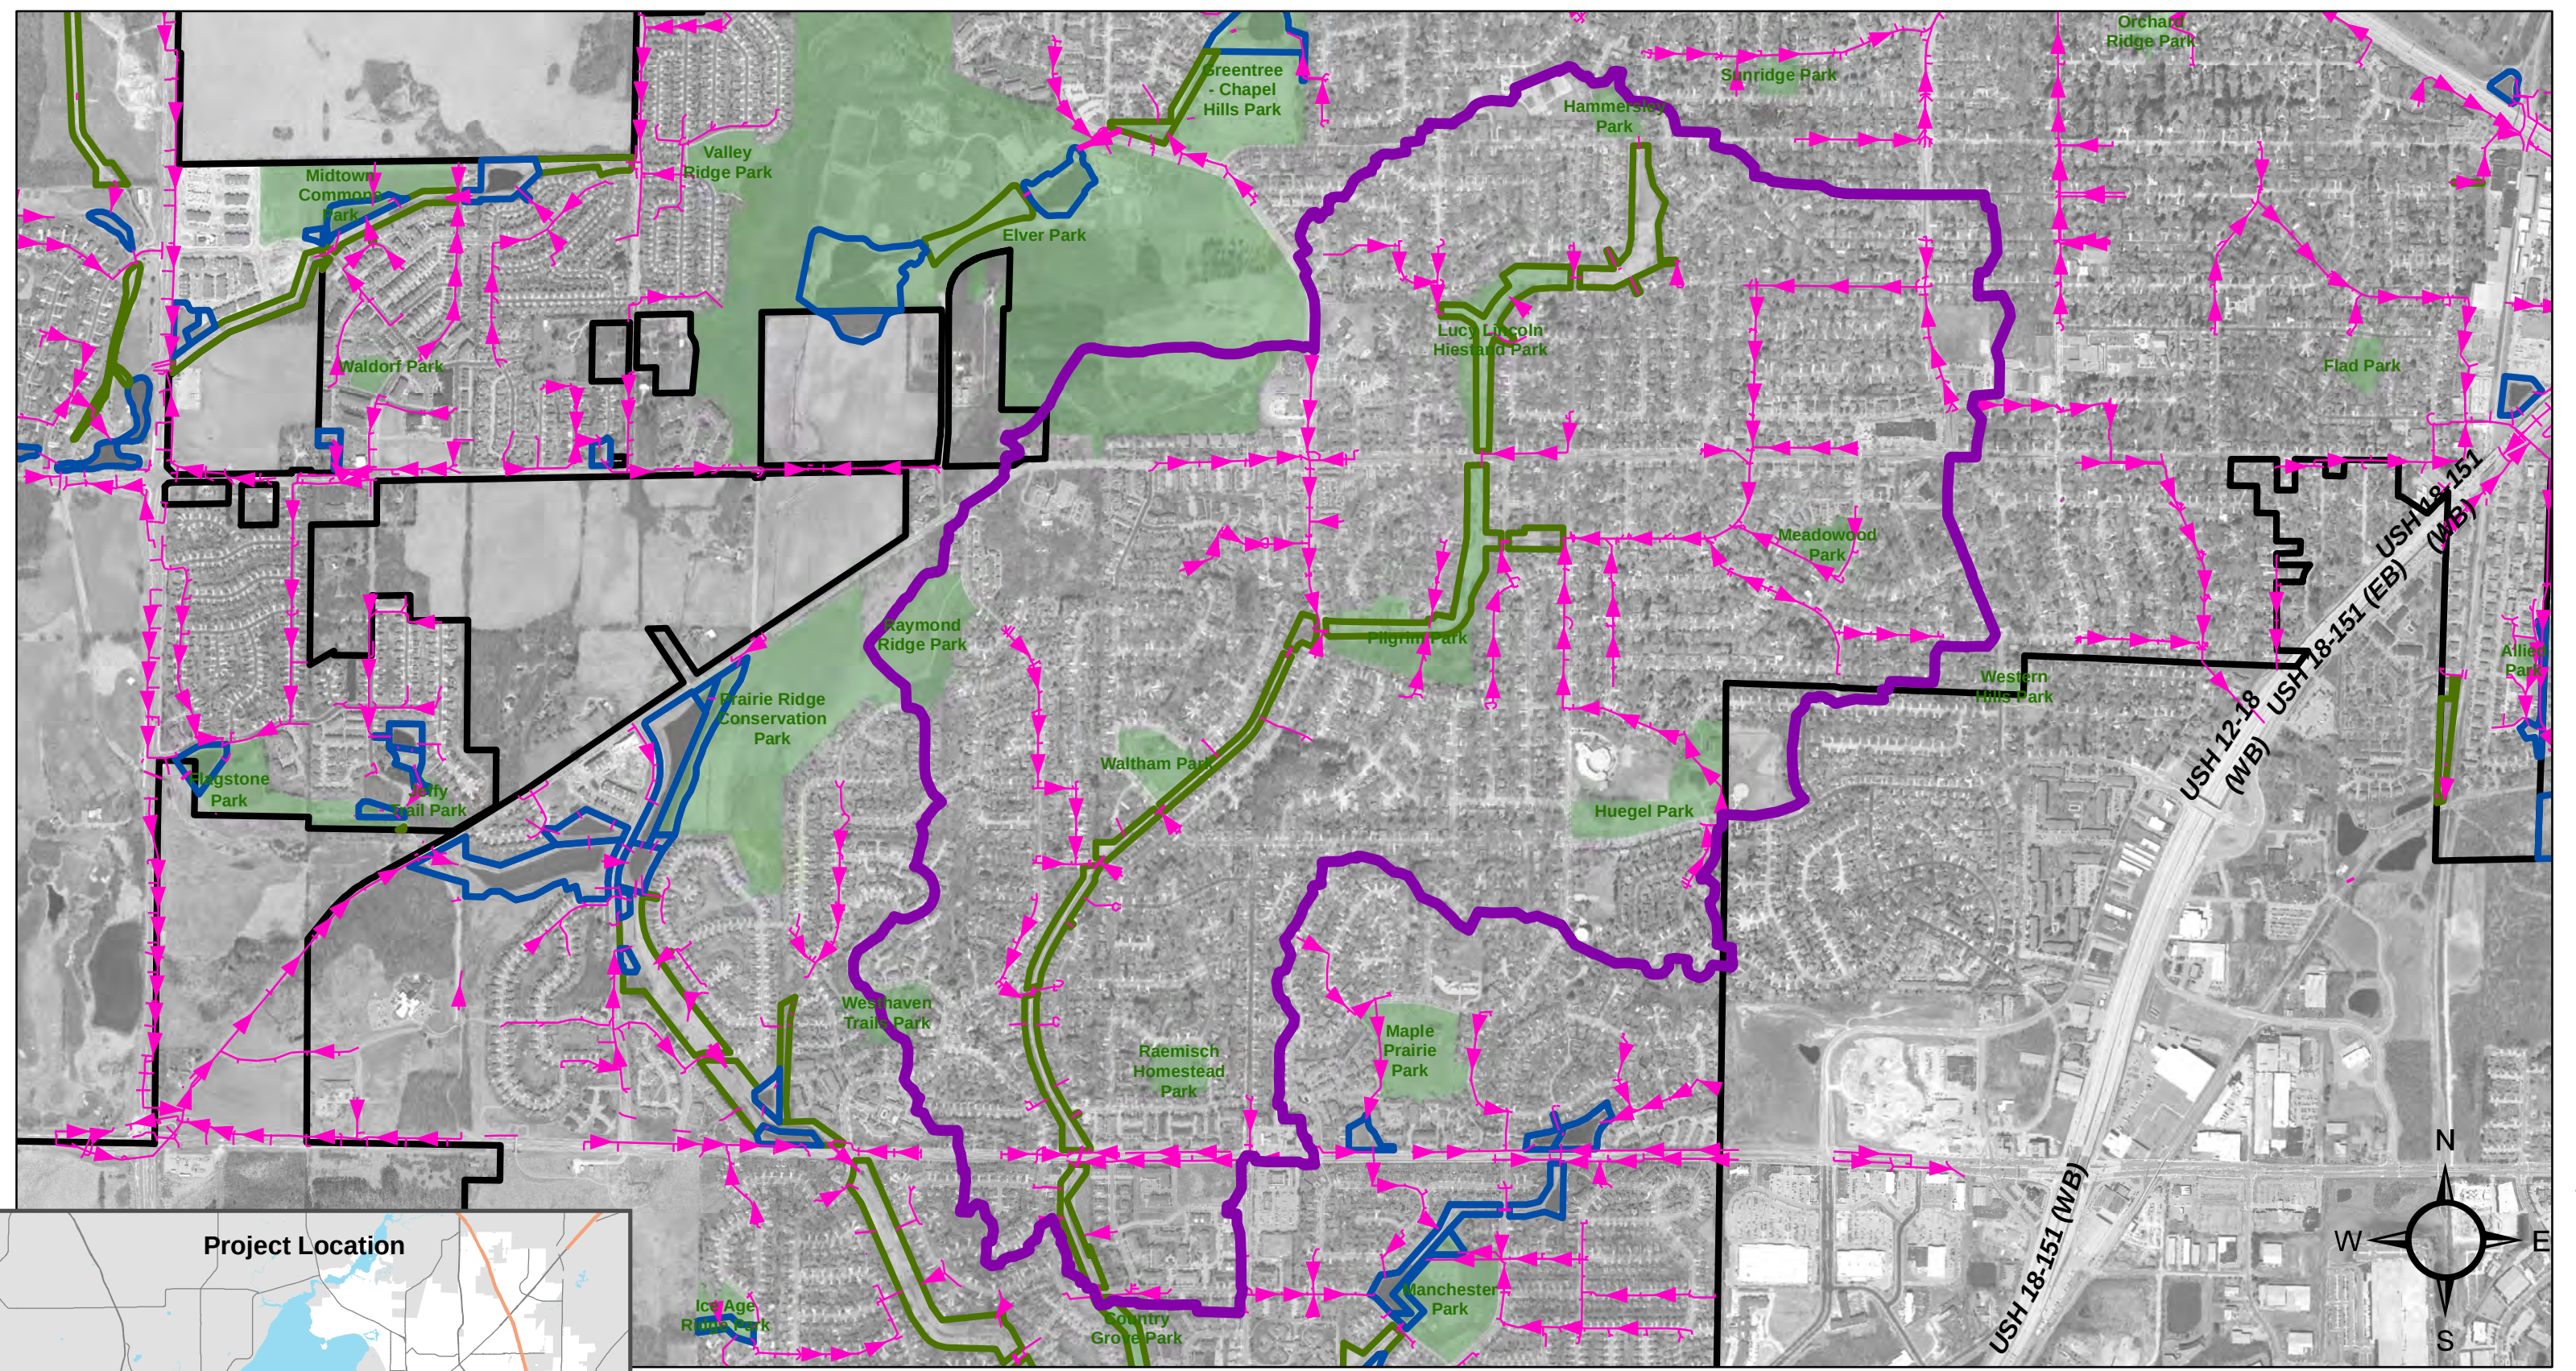
**Figure 4-3**  
**Stormwater Conveyance System**  
**East Badger Mill Creek Watershed**

- Legend**
- Watershed Boundary
  - Storm Pipe
  - Greenway
  - Pond
  - Municipal Limits
  - Park

The 1D hydraulic portion of the PCSWMM model represents the storm sewers and culverts that comprise the drainage system within the East Badger Mill Creek watershed. The hydraulic input parameters required by PCSWMM vary depending on the different parts of the drainage system. The source data used to compile the hydraulic model input data is summarized below. **Appendix C** provides existing and proposed conditions hydraulic input parameters from the PCSWMM model. All elements of the stormwater conveyance system, including storm sewer pipes, structures, culverts, and greenway channels, are displayed in **Figure 4-3**.

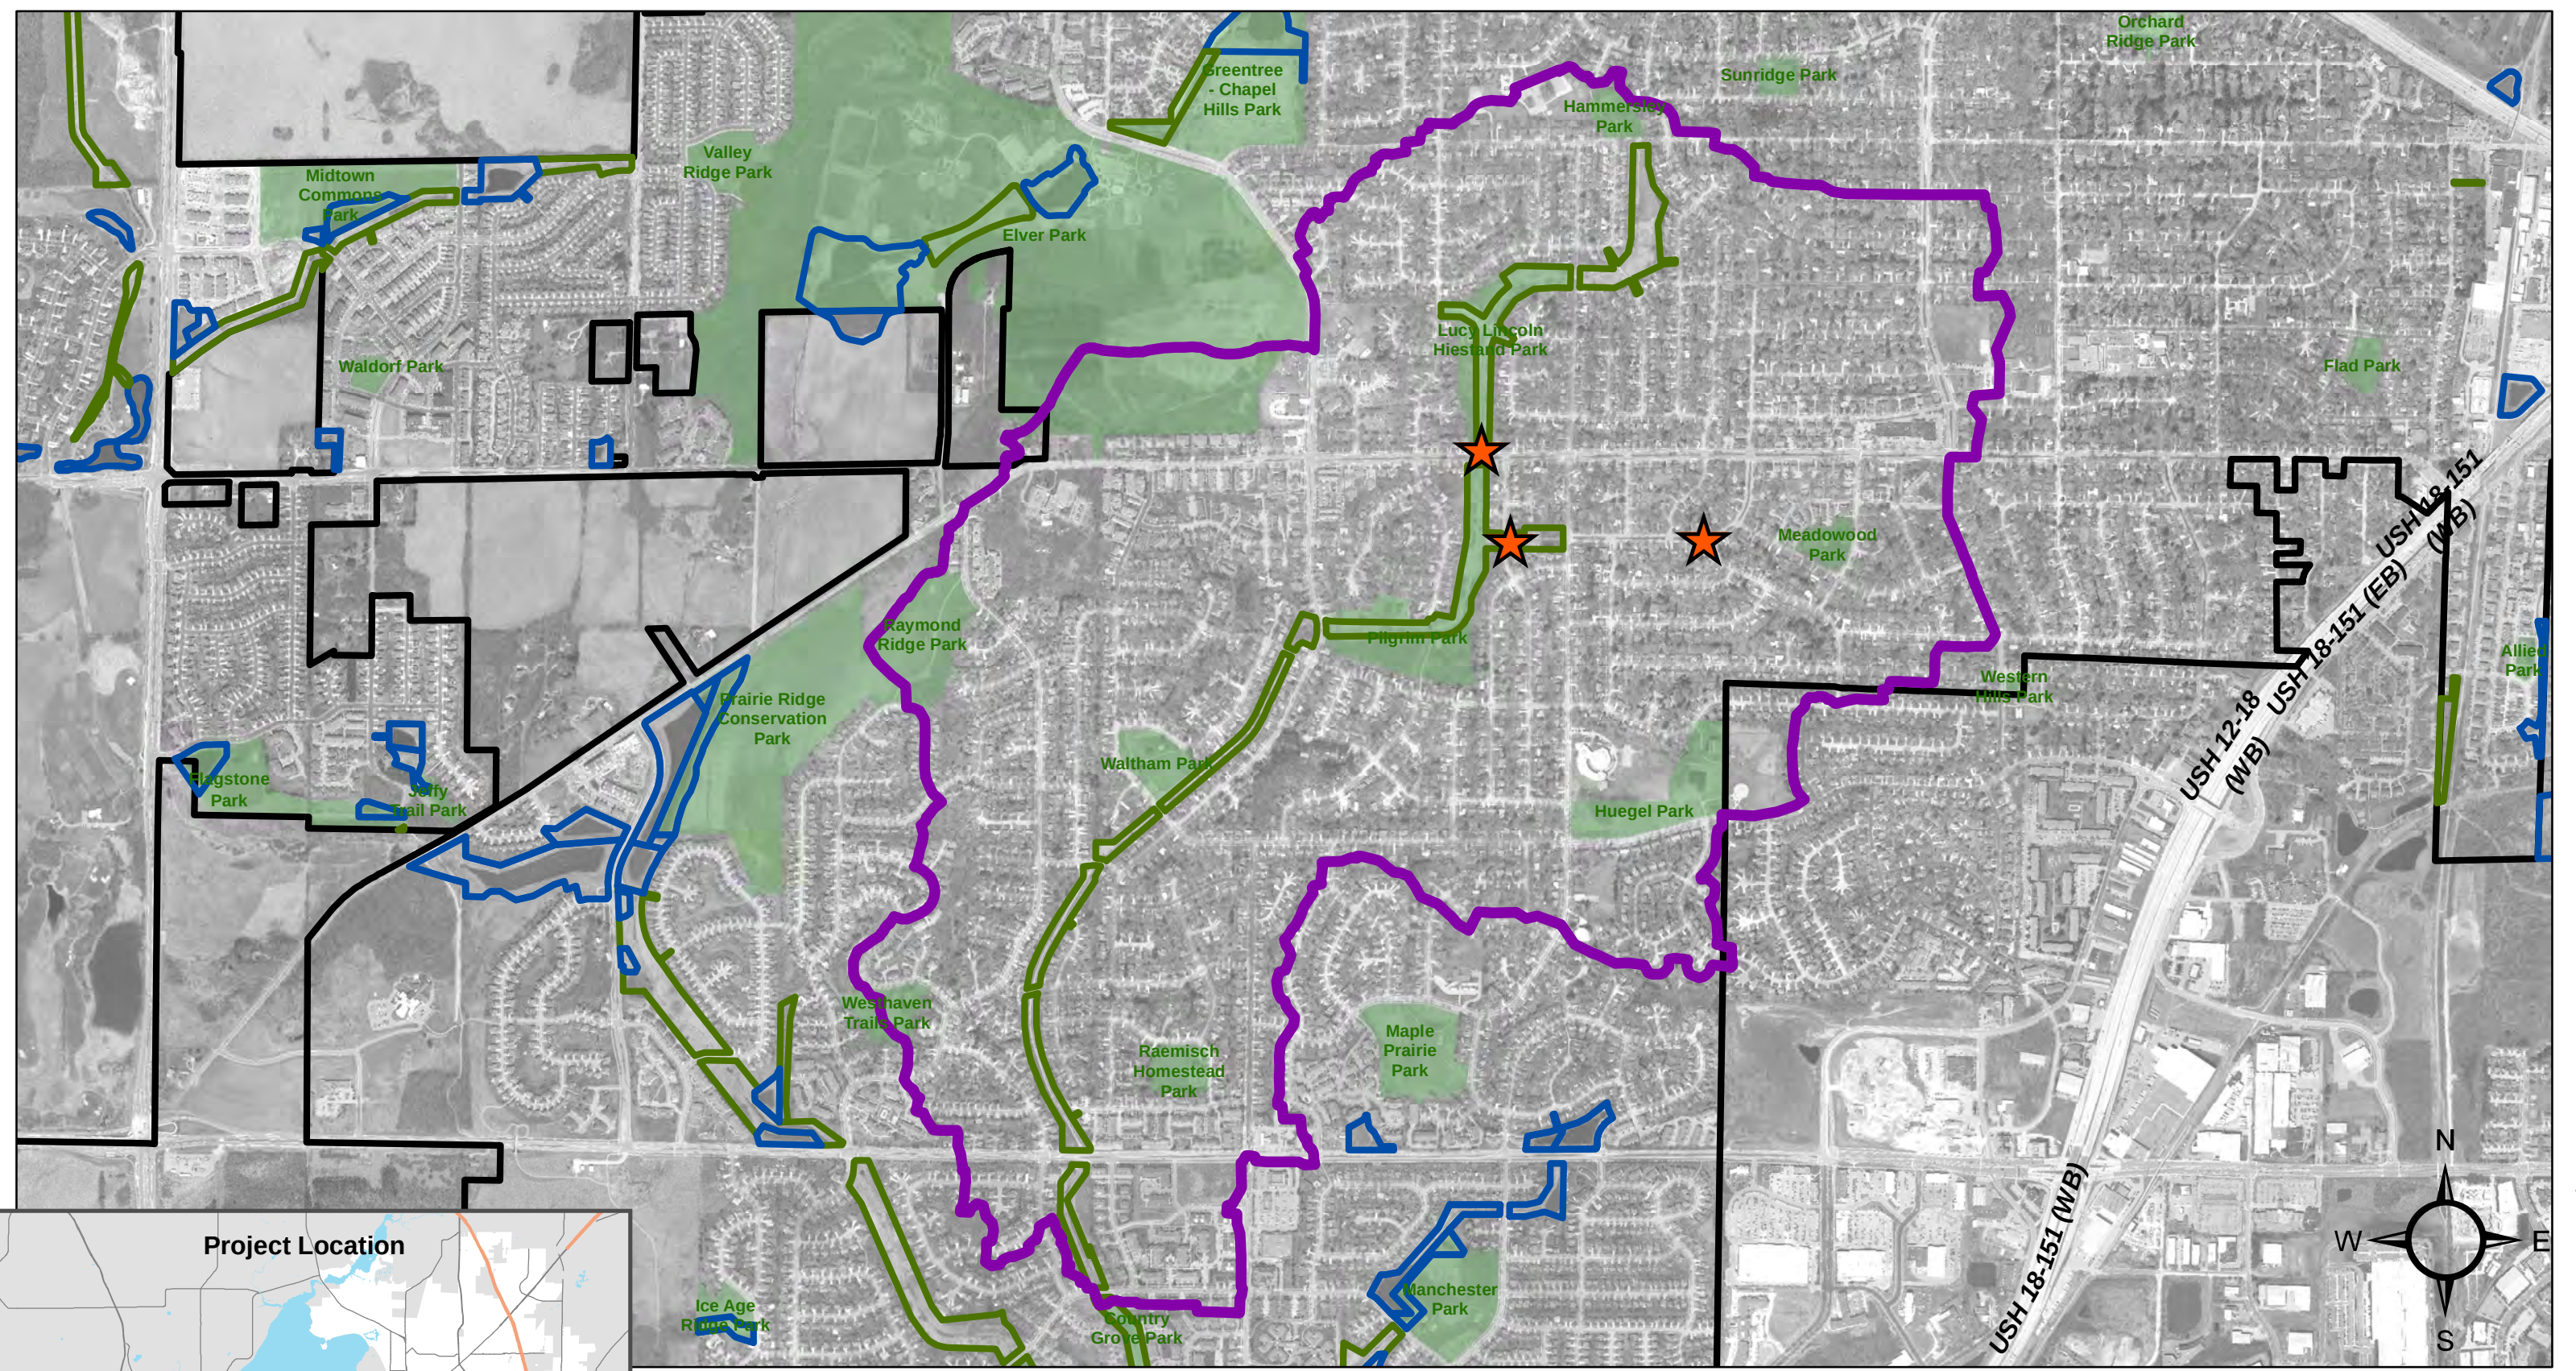
**Figure 5-1**  
**Monitoring Locations**  
**East Badger Mill Creek Watershed**

- Legend**
- Watershed Boundary
  - Greenway
  - Pond
  - Municipal Limits
  - Park
  - Monitoring Locations

There are three monitoring locations within the East Badger Mill Creek watershed that were used as part of the calibration process. These are shown spatially in **Figure 5-1** and are described below.

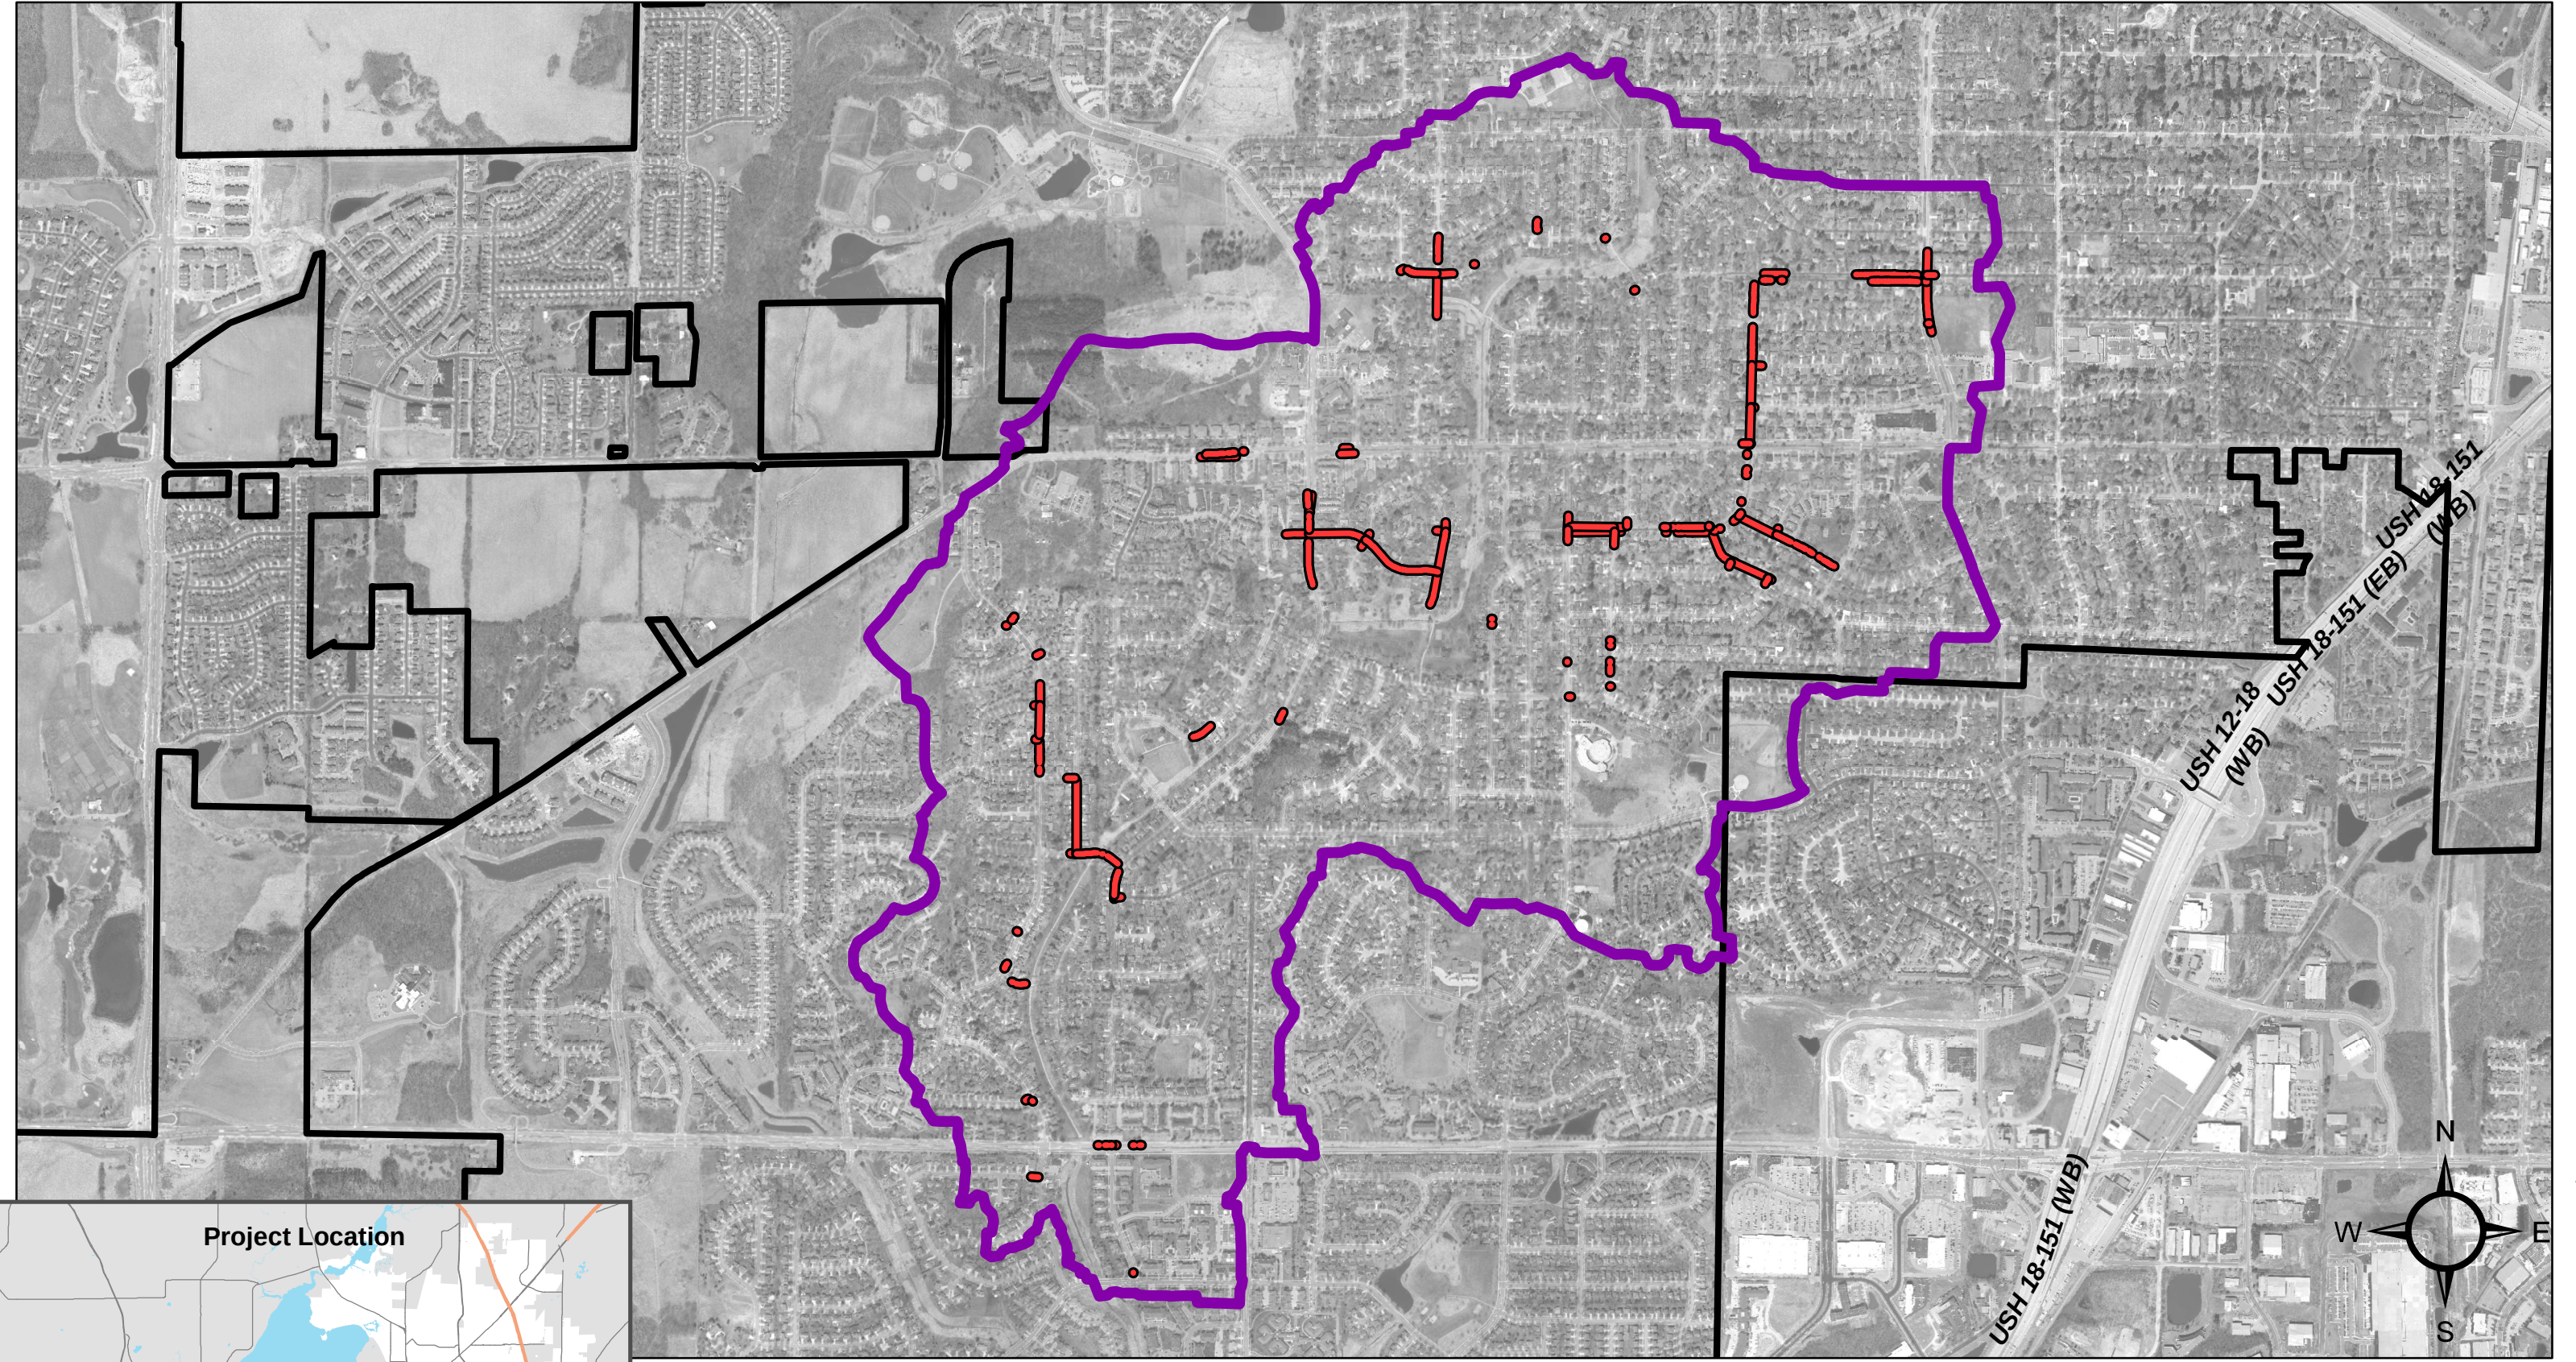
**Figure 6-12**  
**Existing Conditions**  
**Streets Not Meeting 4% Chance Event Target**  
**East Badger Mill Creek Watershed**

- Legend**
- Watershed Boundary
  - Municipal Limits
  - Streets Not Meeting Target

Figure 6-12. Streets Not Meeting 4-Percent Chance Event Target (Existing)

Along streets, the City's target is to maintain drivability of municipal streets for the 4-percent chance event. Drivability is defined as having less than 0.5 feet of flooding along the centerline of the street. Within the watershed there are a total of 35.9 miles of streets, of which 2.47 miles have a water depth of more than 0.5 feet at the street centerline during the 4-percent chance event. This equates to 7 percent of the streets not meeting the target and these sections of street are displayed in **Figure 6-12**. To evaluate street flooding, the Dane County road centerline GIS layer (GISdw.DCL.BuildingFootprint; \_County\_DirectConnection.sde) was intersected with the 1-percent chance inundation extents for depth greater than 0.5 feet.

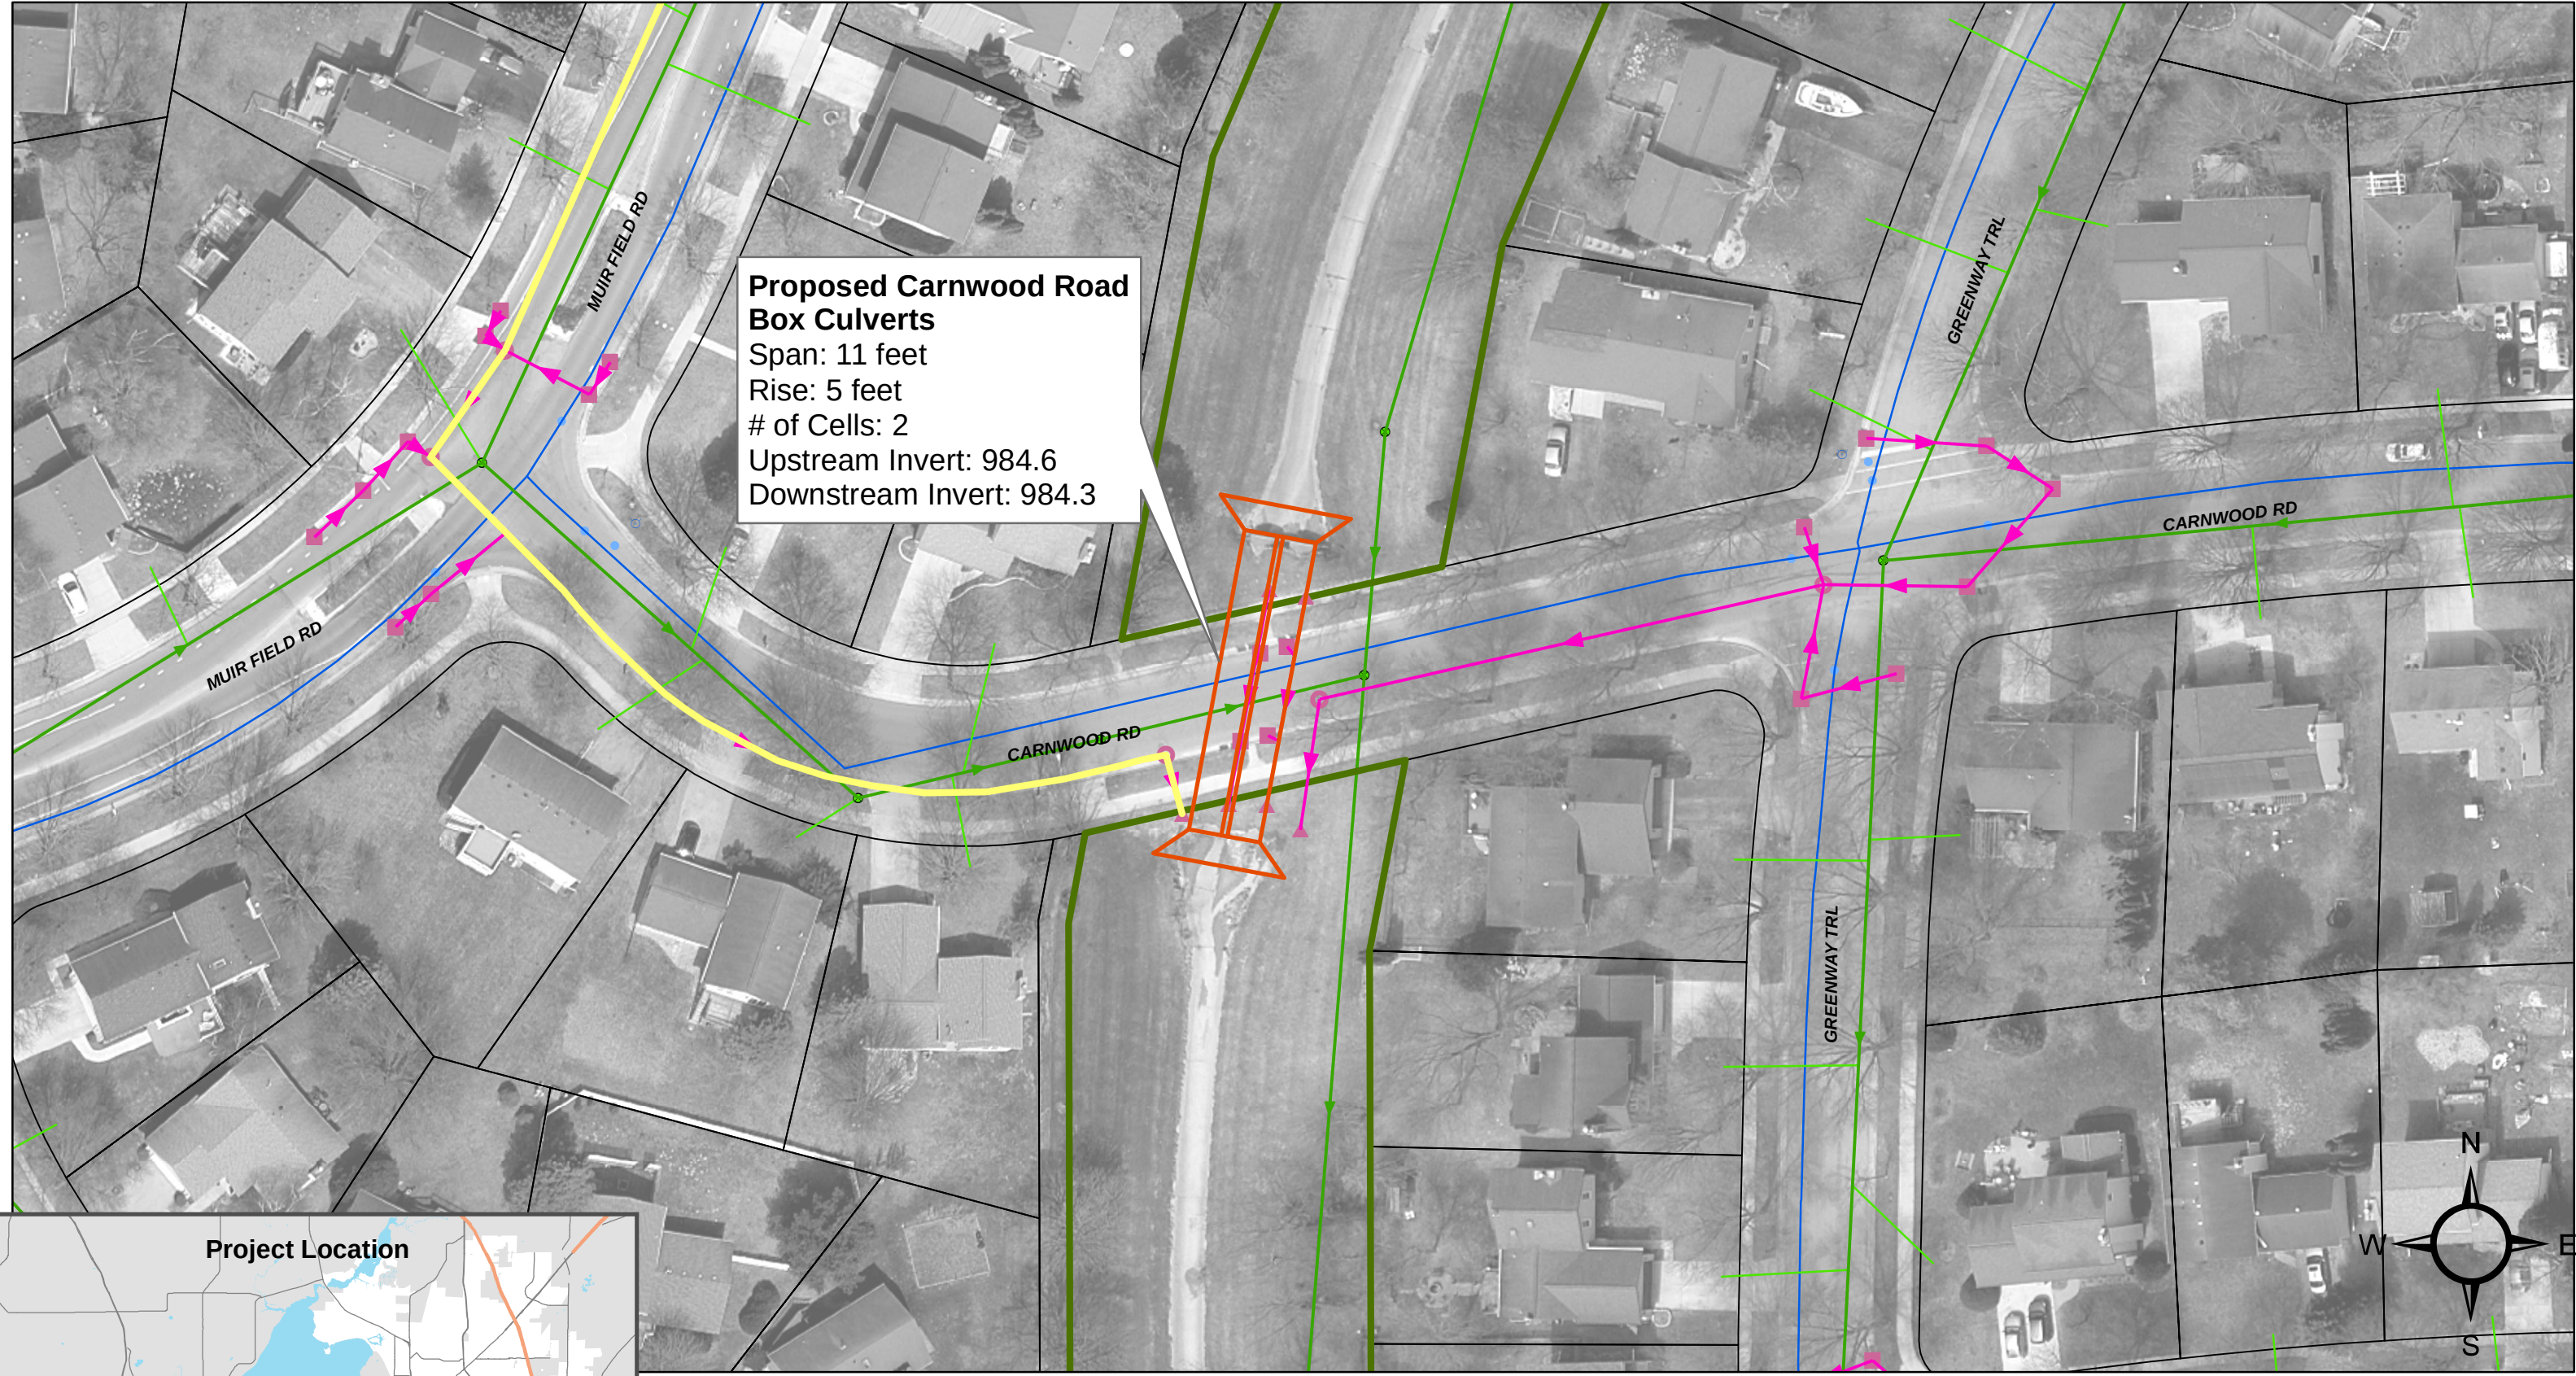
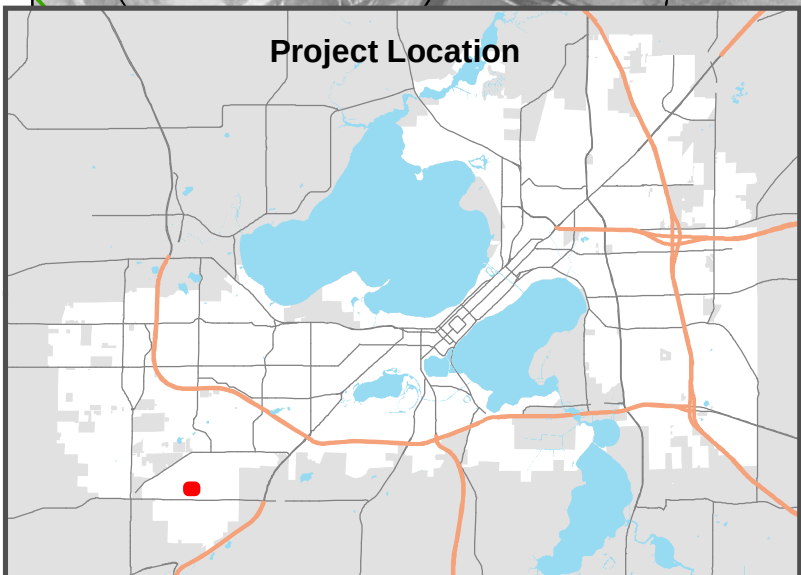
**Figure 9-9**  
**Carnwood Road Box Culverts**  
**East Badger Mill Creek Watershed**

**Proposed Carnwood Road  
Box Culverts**  
 Span: 11 feet  
 Rise: 5 feet  
 # of Cells: 2  
 Upstream Invert: 984.6  
 Downstream Invert: 984.3

3. The modeling and **Figure 9-9** used the assumption that box culvert wingwalls and apron are constructed in accordance with City of Madison S.D.D. 5.5.1 A & B.
