# East Badger Mill Creek Watershed Study Report

City of Madison, WI  
May 18, 2023

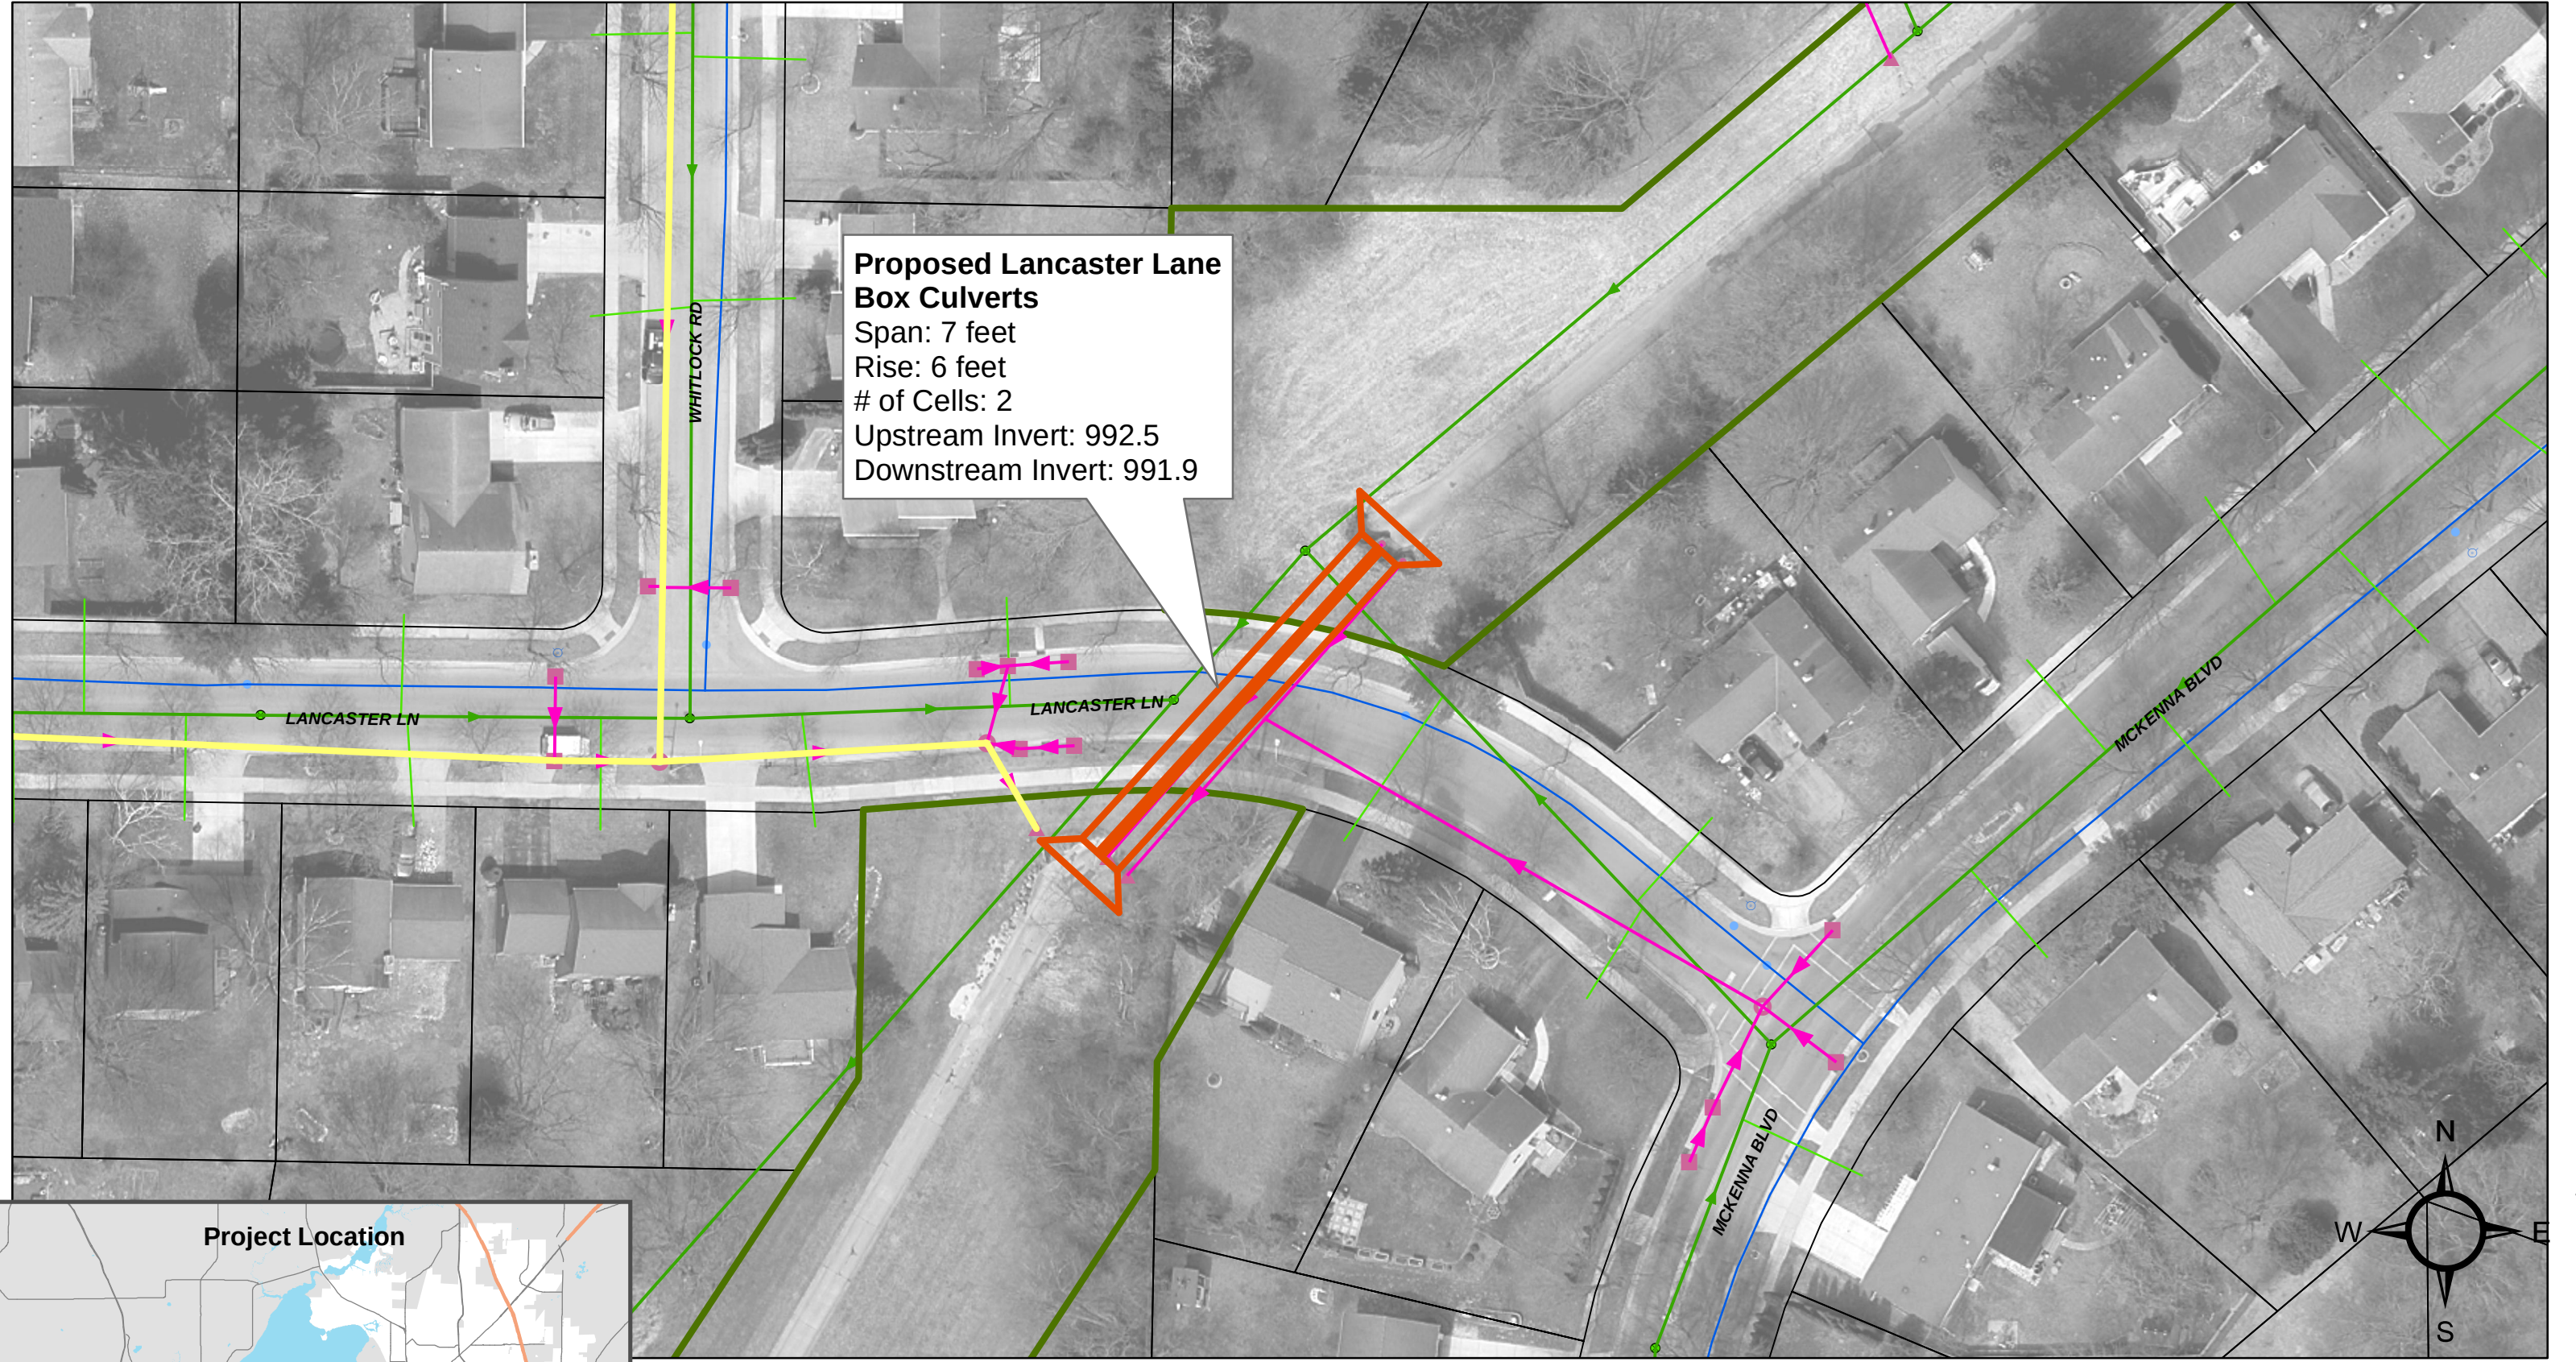
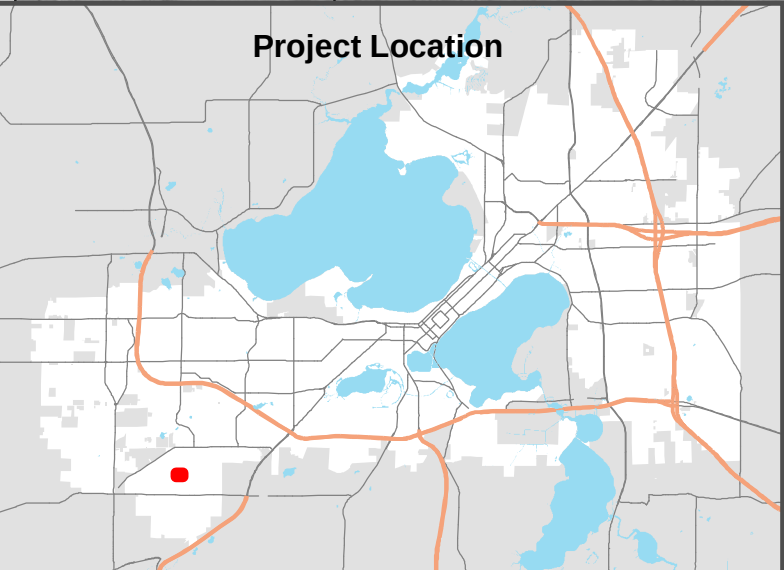
**Figure 9-10**  
**Lancaster Lane Box Culverts**  
**East Badger Mill Creek Watershed**

**Proposed Lancaster Lane Box Culverts**  
Span: 7 feet  
Rise: 6 feet  
# of Cells: 2  
Upstream Invert: 992.5  
Downstream Invert: 991.9

Two 7' span x 6' rise box culverts would need to be installed at the Lancaster Lane greenway crossing to replace the two existing 72" diameter RCP culverts. This greenway crossing and elements of the project are displayed in **Figure 9-10**.

2. The new box culverts need to be installed at the invert elevations indicated in **Figure 9-10**. These were set to balance upstream high water elevations and flow conveyed downstream, as well as providing just enough cover for a typical culvert crossing installation.

3. The modeling and **Figure 9-10** used the assumption that box culvert wingwalls and apron are constructed in accordance with City of Madison S.D.D. 5.5.1 A & B.

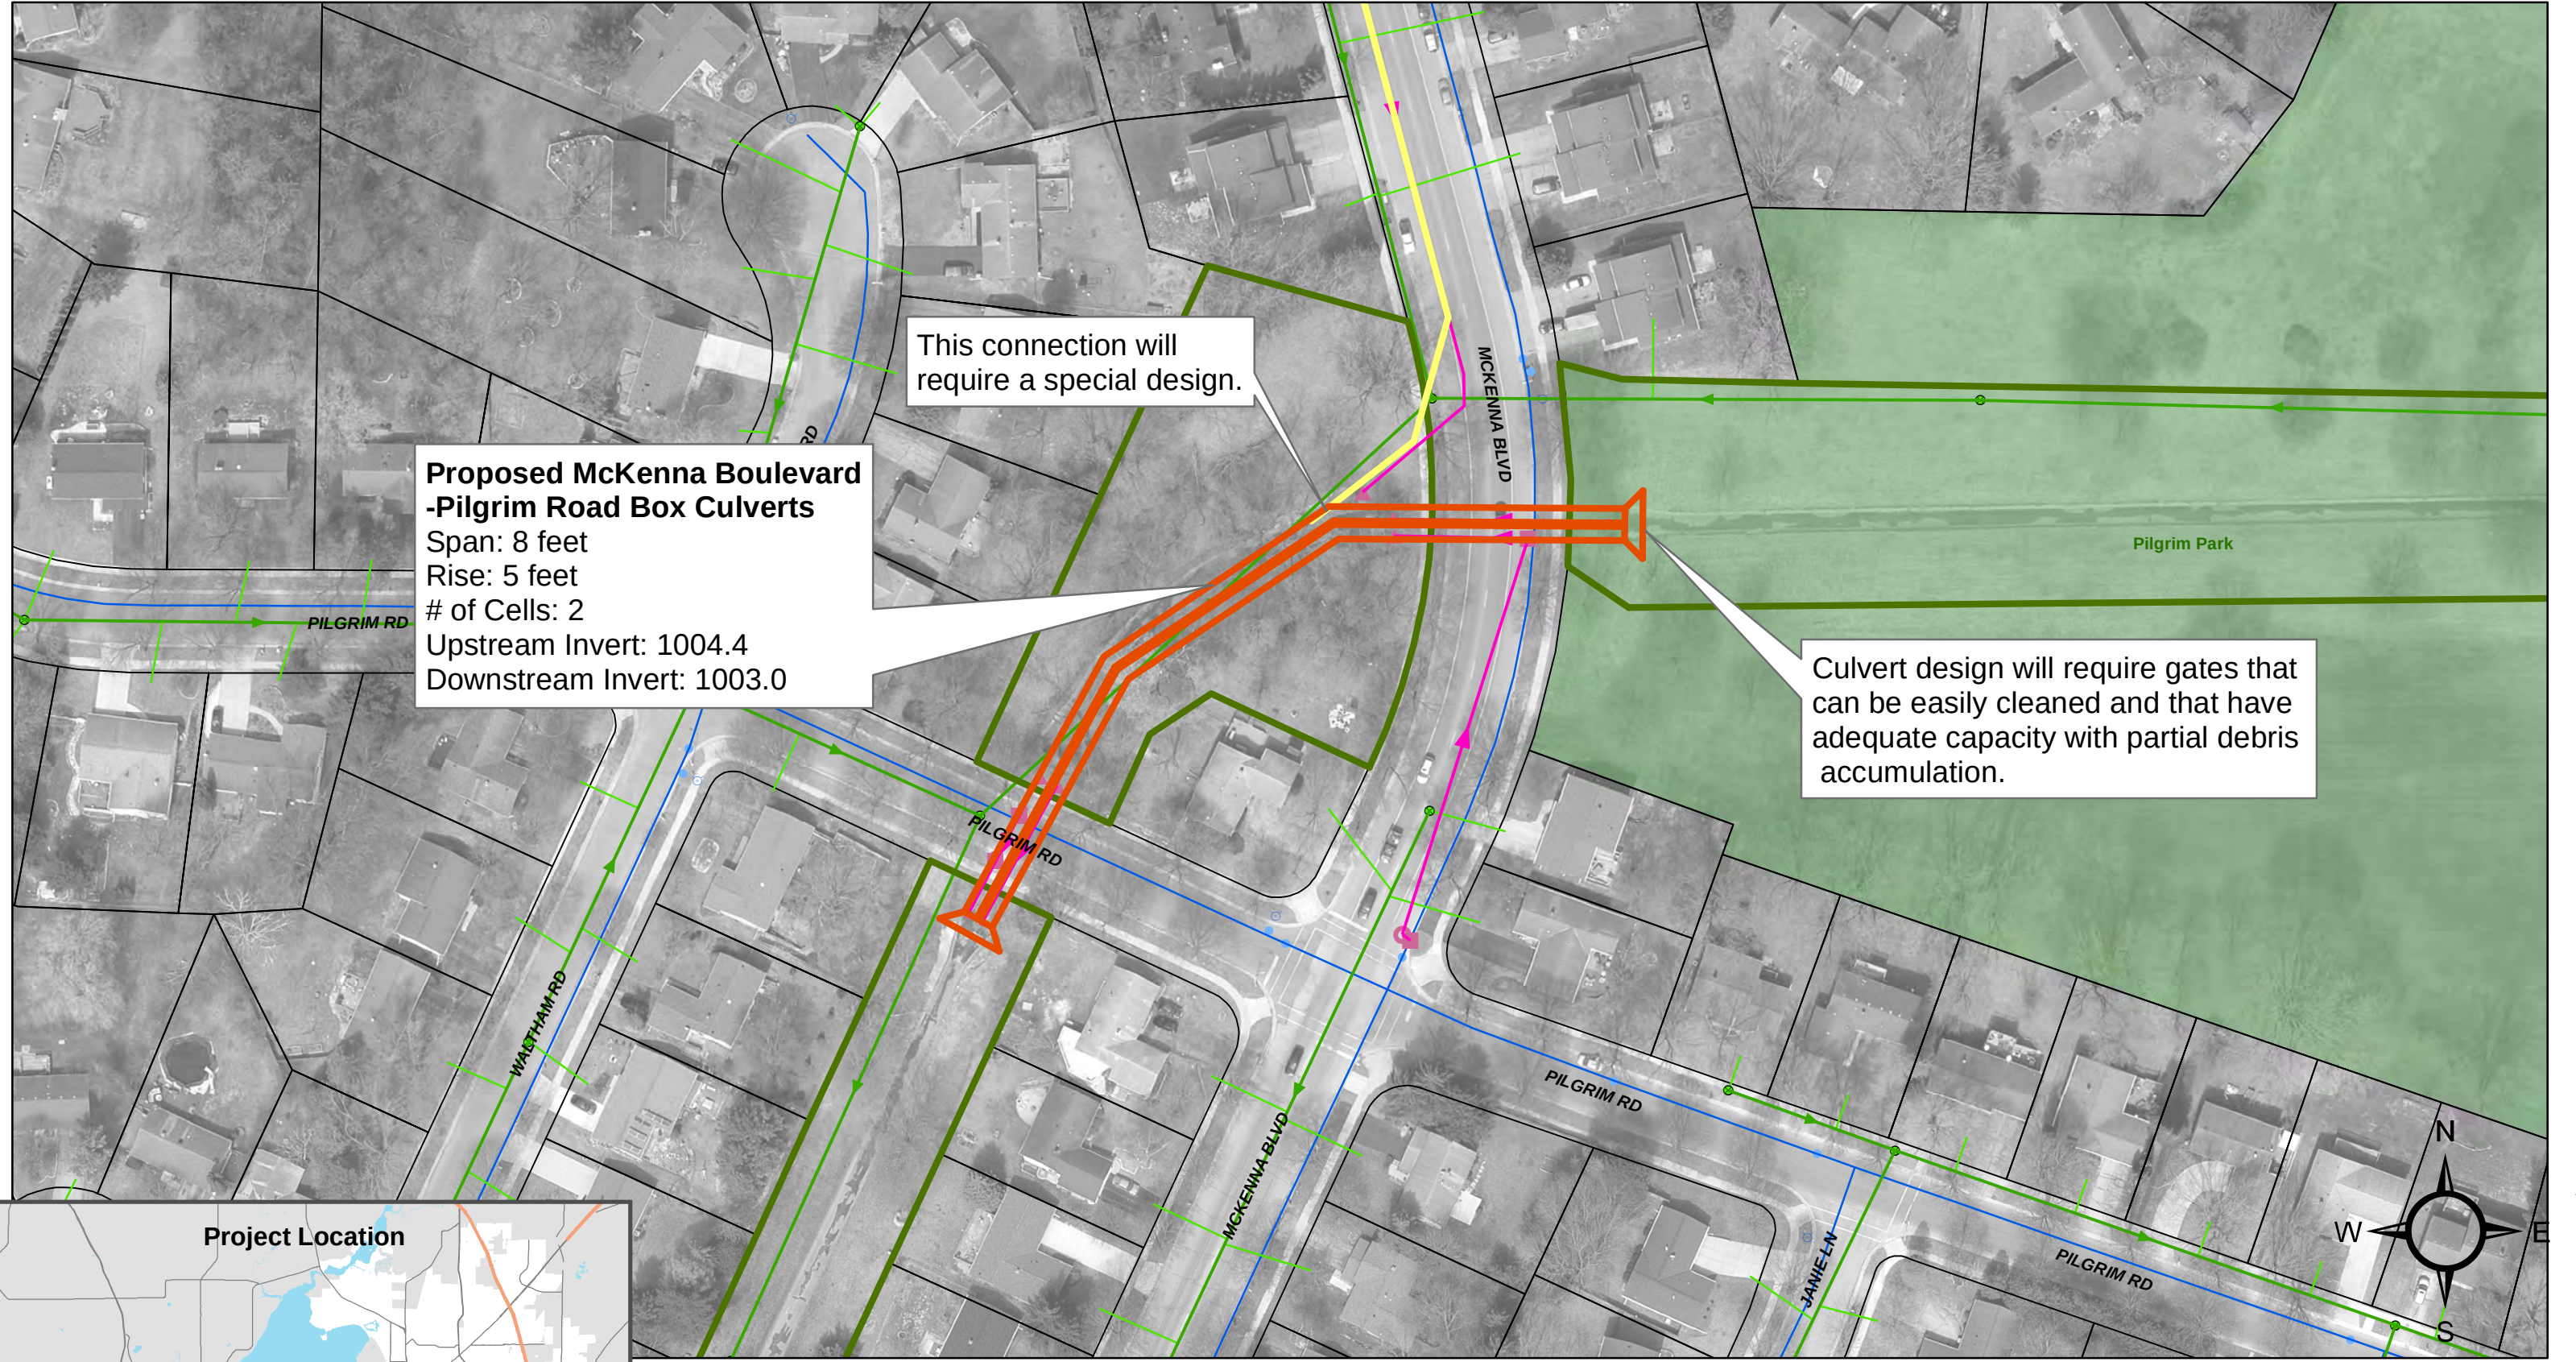
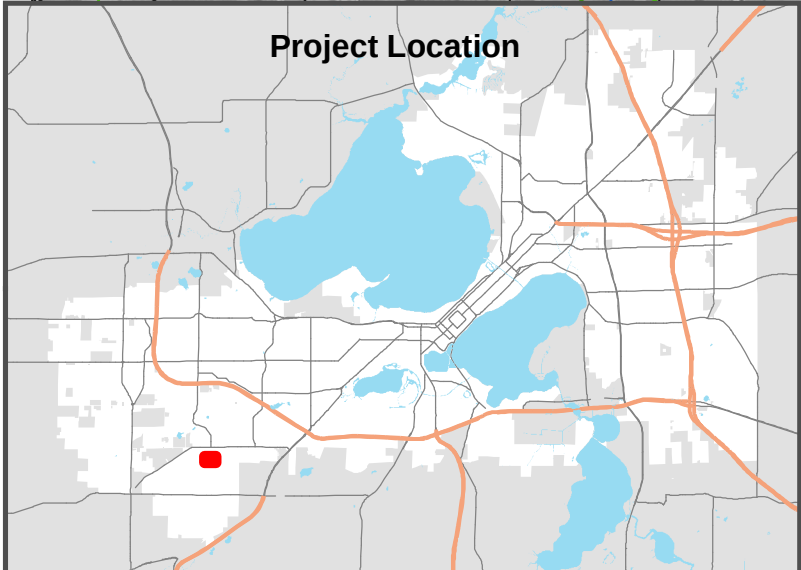
**Figure 9-12**  
**McKenna Boulevard-Pilgrim**  
**Road Box Culverts**  
**East Badger Mill Creek Watershed**

**Proposed McKenna Boulevard  
-Pilgrim Road Box Culverts**  
Span: 8 feet  
Rise: 5 feet  
# of Cells: 2  
Upstream Invert: 1004.4  
Downstream Invert: 1003.0

This connection will  
require a special design.

Culvert design will require gates that  
can be easily cleaned and that have  
adequate capacity with partial debris  
accumulation.

Two 8' span x 5' rise box culverts would need to be installed at the McKenna Boulevard-Pilgrim Road greenway crossing to replace the two existing 72" diameter RCP culverts. The two existing greenway crossings are recommended to be combined into one to reduce the impact of hydraulic losses present in the existing configuration. This greenway crossing and elements of the project are displayed in **Figure 9-12**.

1. The project is intended to be designed and constructed as a spot replacement of culverts.
2. The new box culverts need to be installed at the invert elevations indicated in **Figure 9-12**. These were set to balance upstream high water elevations and flow conveyed downstream.
3. The modeling and **Figure 9-12** used the assumption that box culvert wingwalls and apron are constructed in accordance with City of Madison S.D.D. 5.5.1 A & B.
4. The connection between a new box culvert along McKenna Boulevard, described in Section 9.3, and the box culverts at this crossing will require detailed planning and design.

5. Bends will need to be used on both culverts to achieve the layout displayed in **Figure 9-12**. These will need special design and will require additional attention during installation.

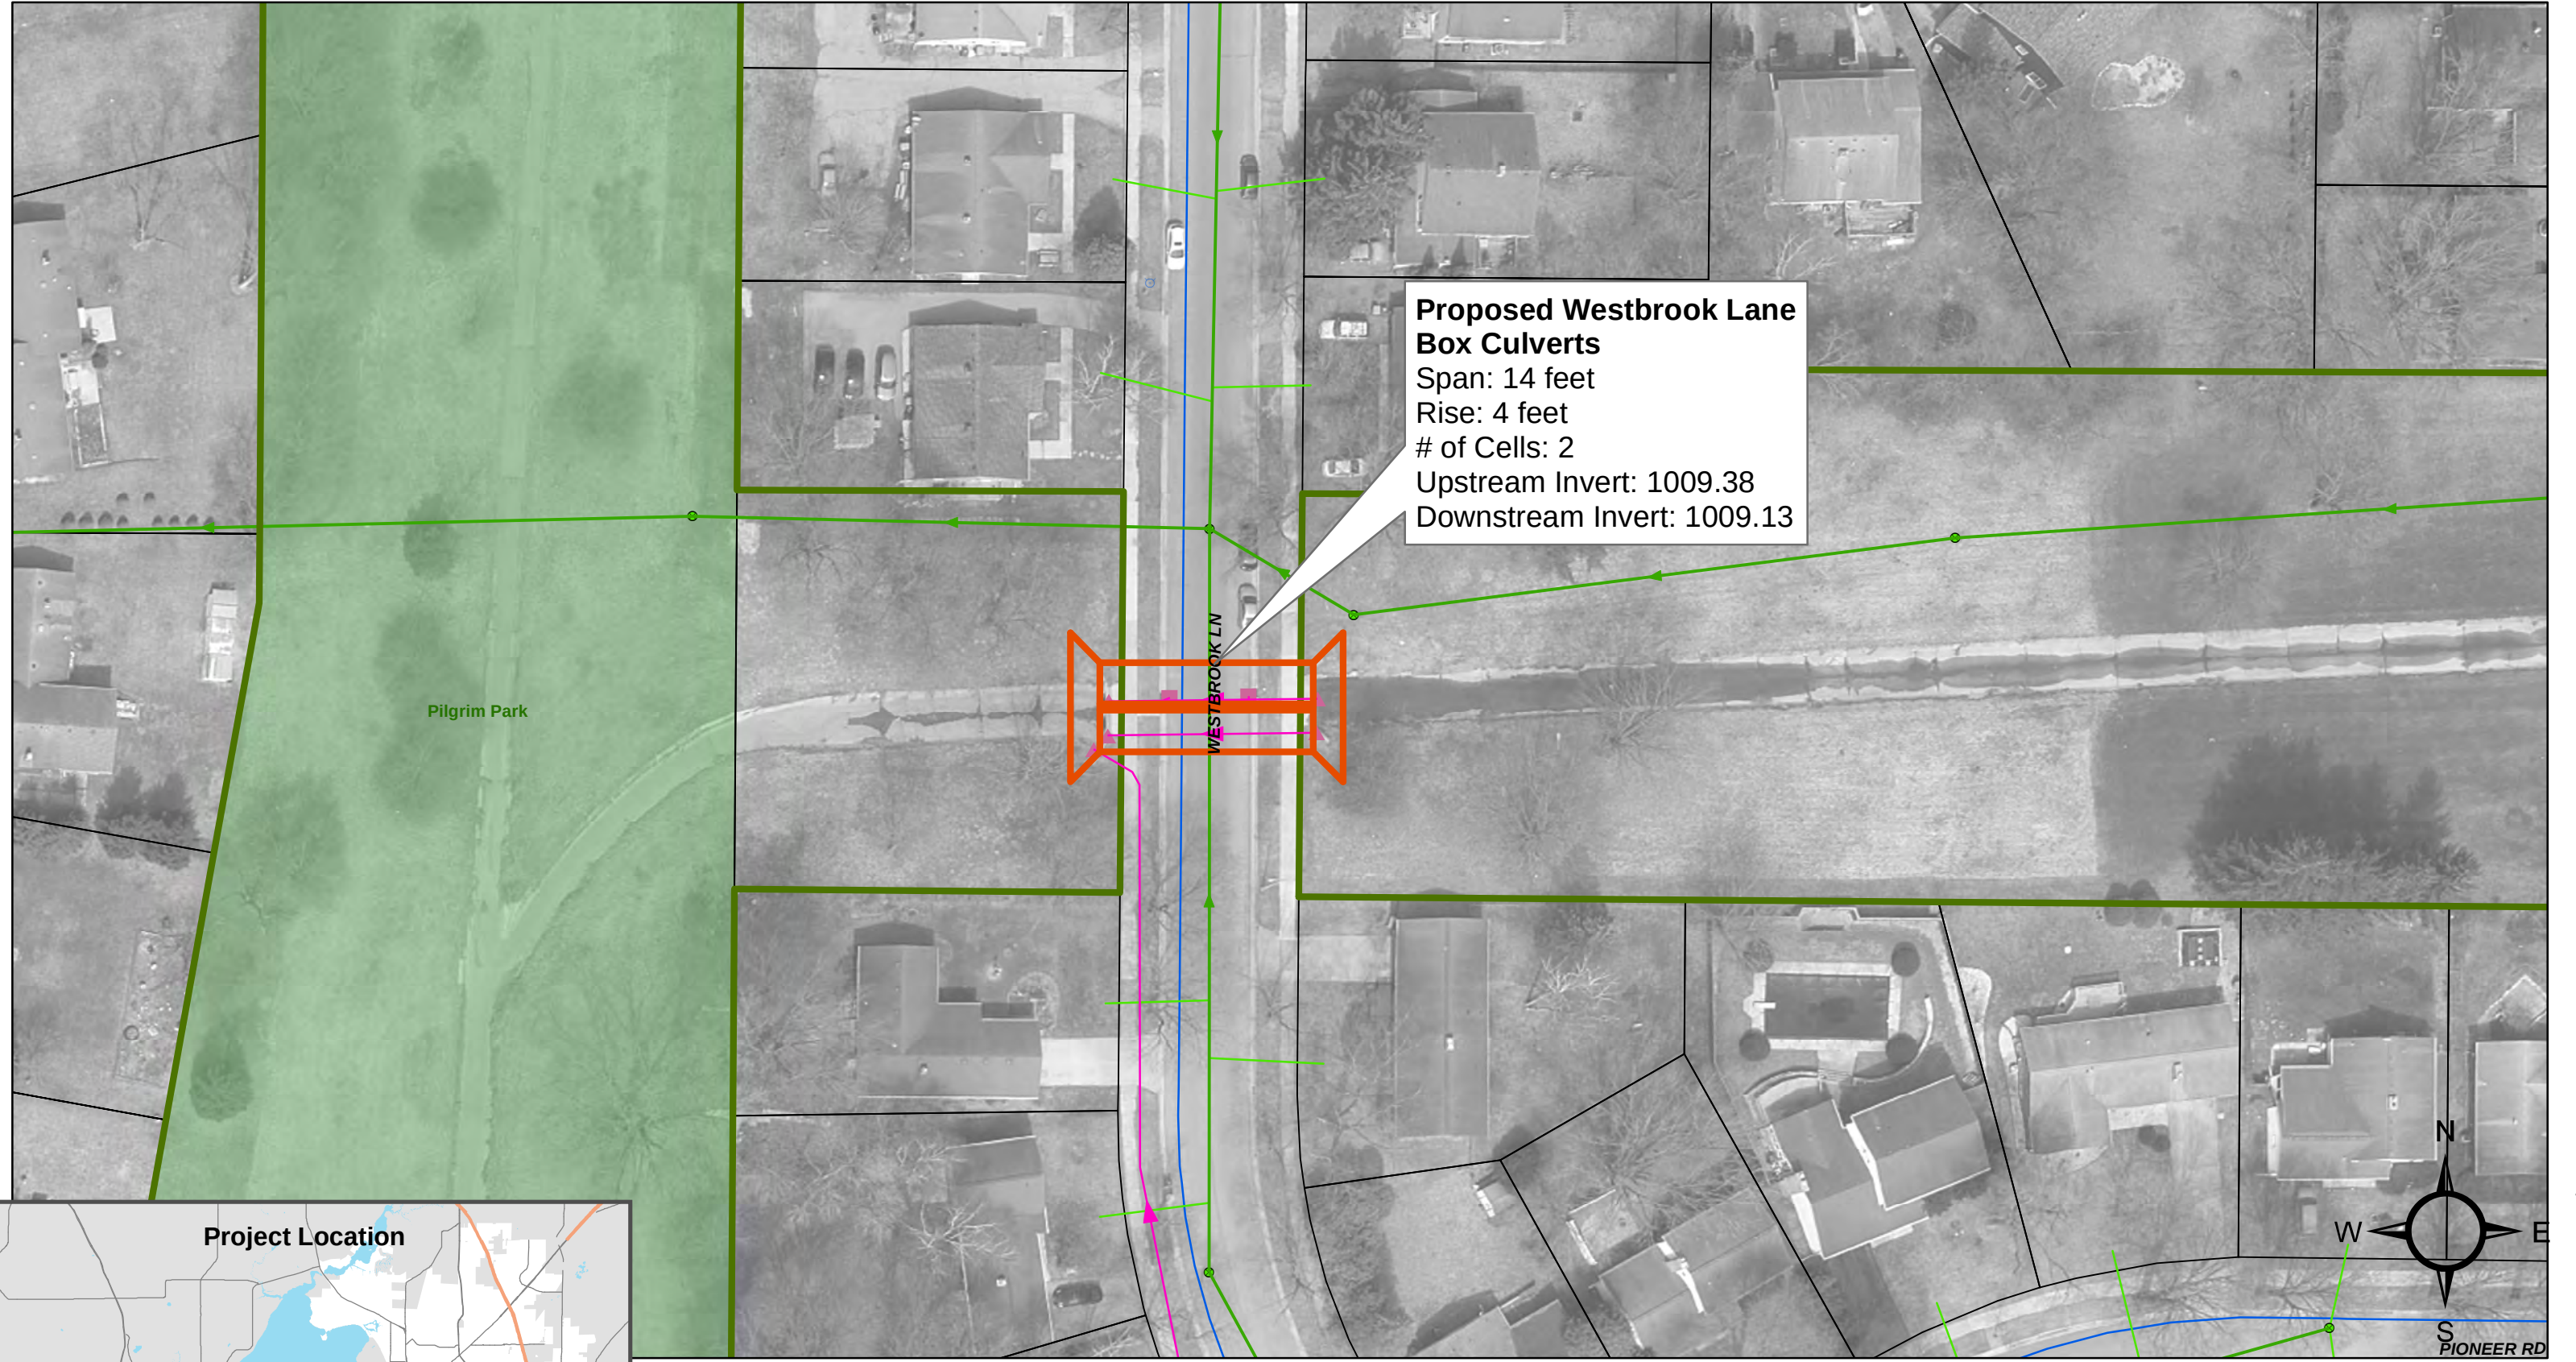
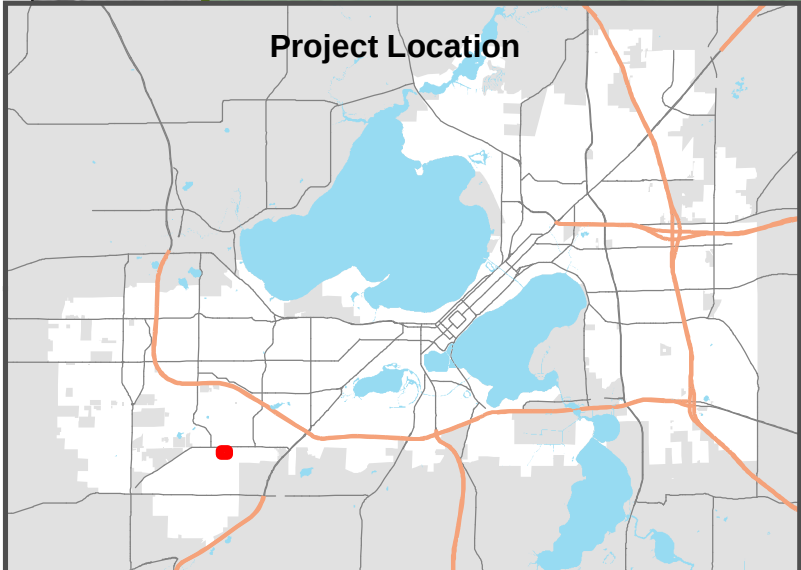
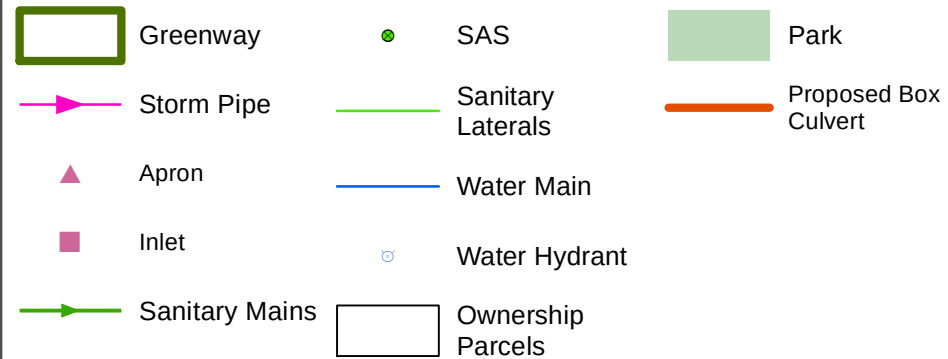
**Figure 9-13**  
**Westbrook Lane Box Culverts**  
**East Badger Mill Creek Watershed**

**Proposed Westbrook Lane  
Box Culverts**  
Span: 14 feet  
Rise: 4 feet  
# of Cells: 2  
Upstream Invert: 1009.38  
Downstream Invert: 1009.13

Two 14' span x 4' rise box culverts would need to be installed at the Westbrook Lane greenway crossing to replace the two existing 47"x71" corrugated metal pipe arch culverts. This greenway crossing and elements of the project are displayed in **Figure 9-13**.

1. The project is intended to be designed and constructed as a spot replacement of culverts.
2. The new box culverts need to be installed at the invert elevations indicated in **Figure 9-13**. These were set to balance upstream high water elevations and flow conveyed downstream.
3. The modeling and **Figure 9-13** used the assumption that box culvert wingwalls and apron are constructed in accordance with City of Madison S.D.D. 5.5.1 A & B.
4. Field observation shows that existing wingwalls on this culvert are beginning to fail. Rather than structurally repair the existing wingwalls, the proposed box culverts can be installed when the

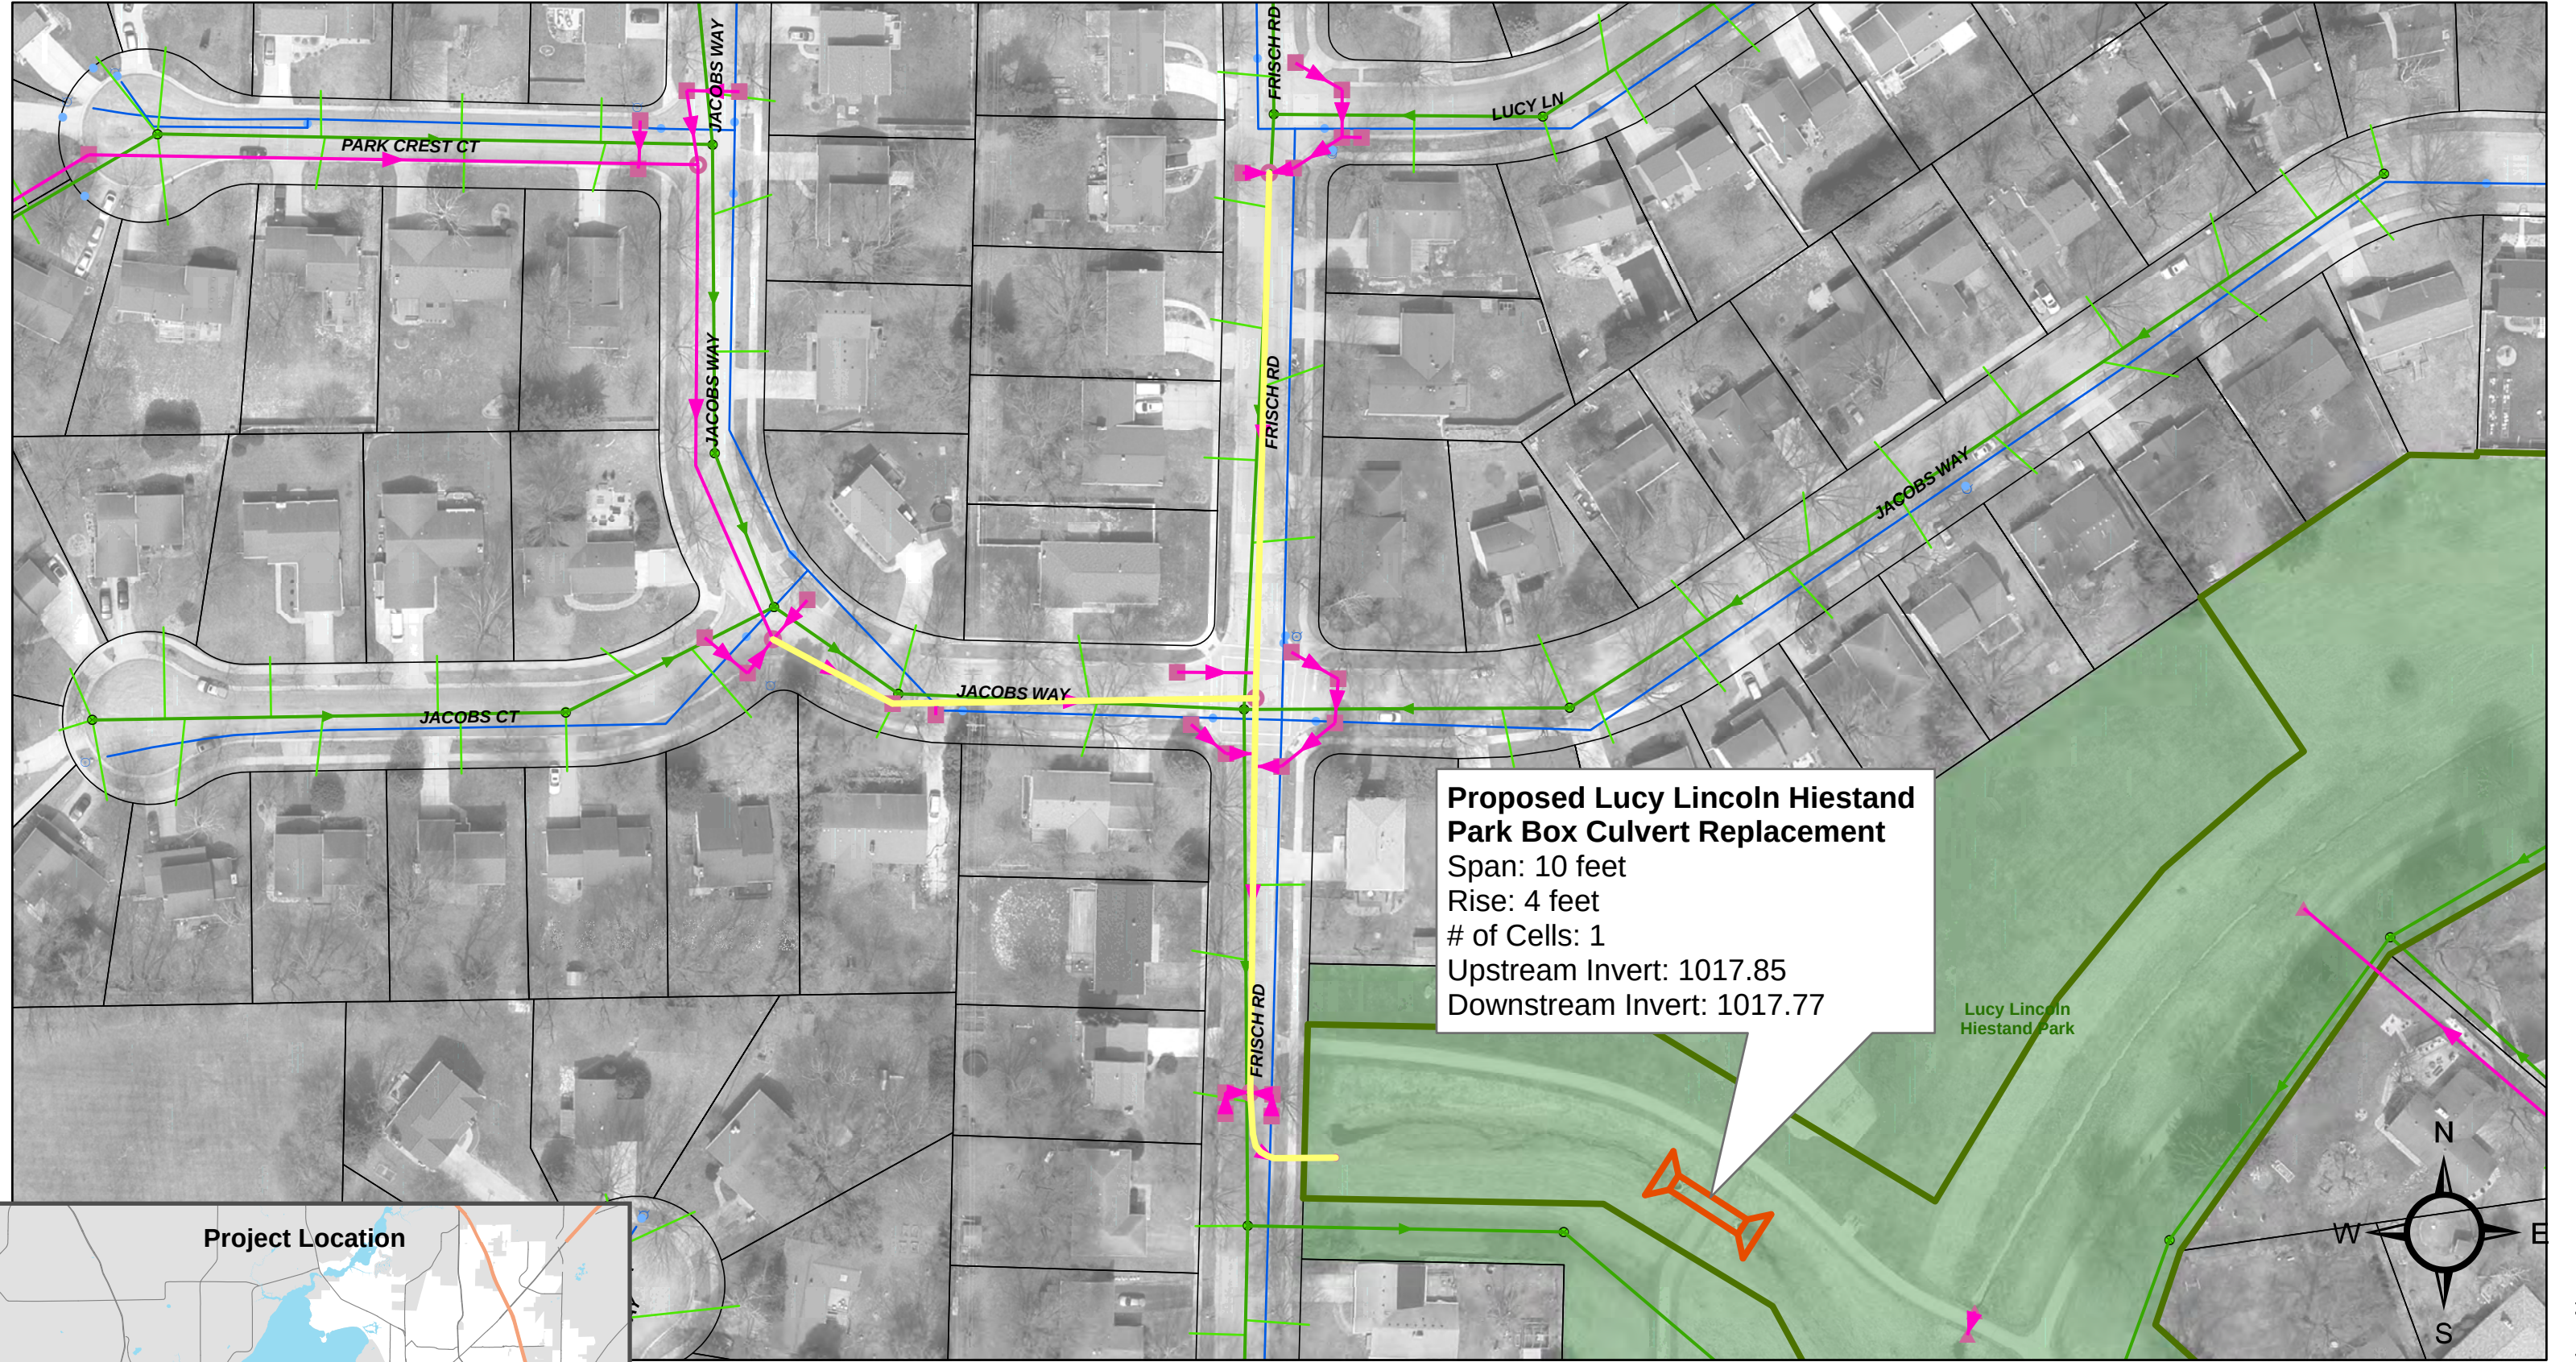
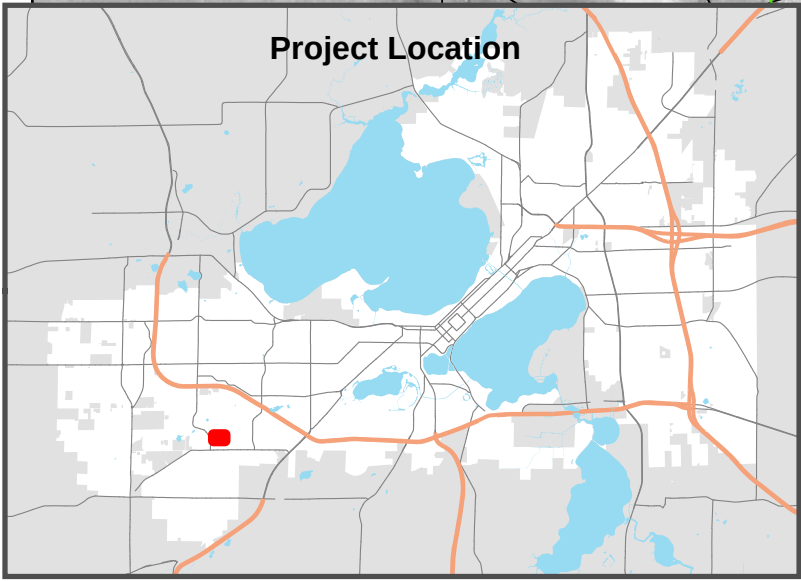
**Figure 9-14**  
**Lucy Lincoln Hiestand Park Culvert**  
**and Frisch Road Storm Sewer**  
**East Badger Mill Creek Watershed**

**Proposed Lucy Lincoln Hiestand  
Park Box Culvert Replacement**  
 Span: 10 feet  
 Rise: 4 feet  
 # of Cells: 1  
 Upstream Invert: 1017.85  
 Downstream Invert: 1017.77

One 10' span x 4' rise box culvert would need to be installed at the path greenway crossing in Lucy Lincoln Hiestand Park, just west of the Frisch Road greenway outfall, to replace the existing 34"x53" HERCP culvert. Additional improvements include installing upsized storm sewer along Frisch Road to about 600 feet of north of the greenway outfall, installing upsized storm sewer along Jacobs Way to about 300 feet west of the intersection with Frisch Road, and increased inlet capacity. This greenway crossing and elements of the project are displayed in **Figure 9-14**.

1. The project is intended to be designed and constructed as a spot replacement of culverts.
2. The modeling and **Figure 9-14** used the assumption that box culvert wingwalls and apron are constructed in accordance with City of Madison S.D.D. 5.5.1 A & B.

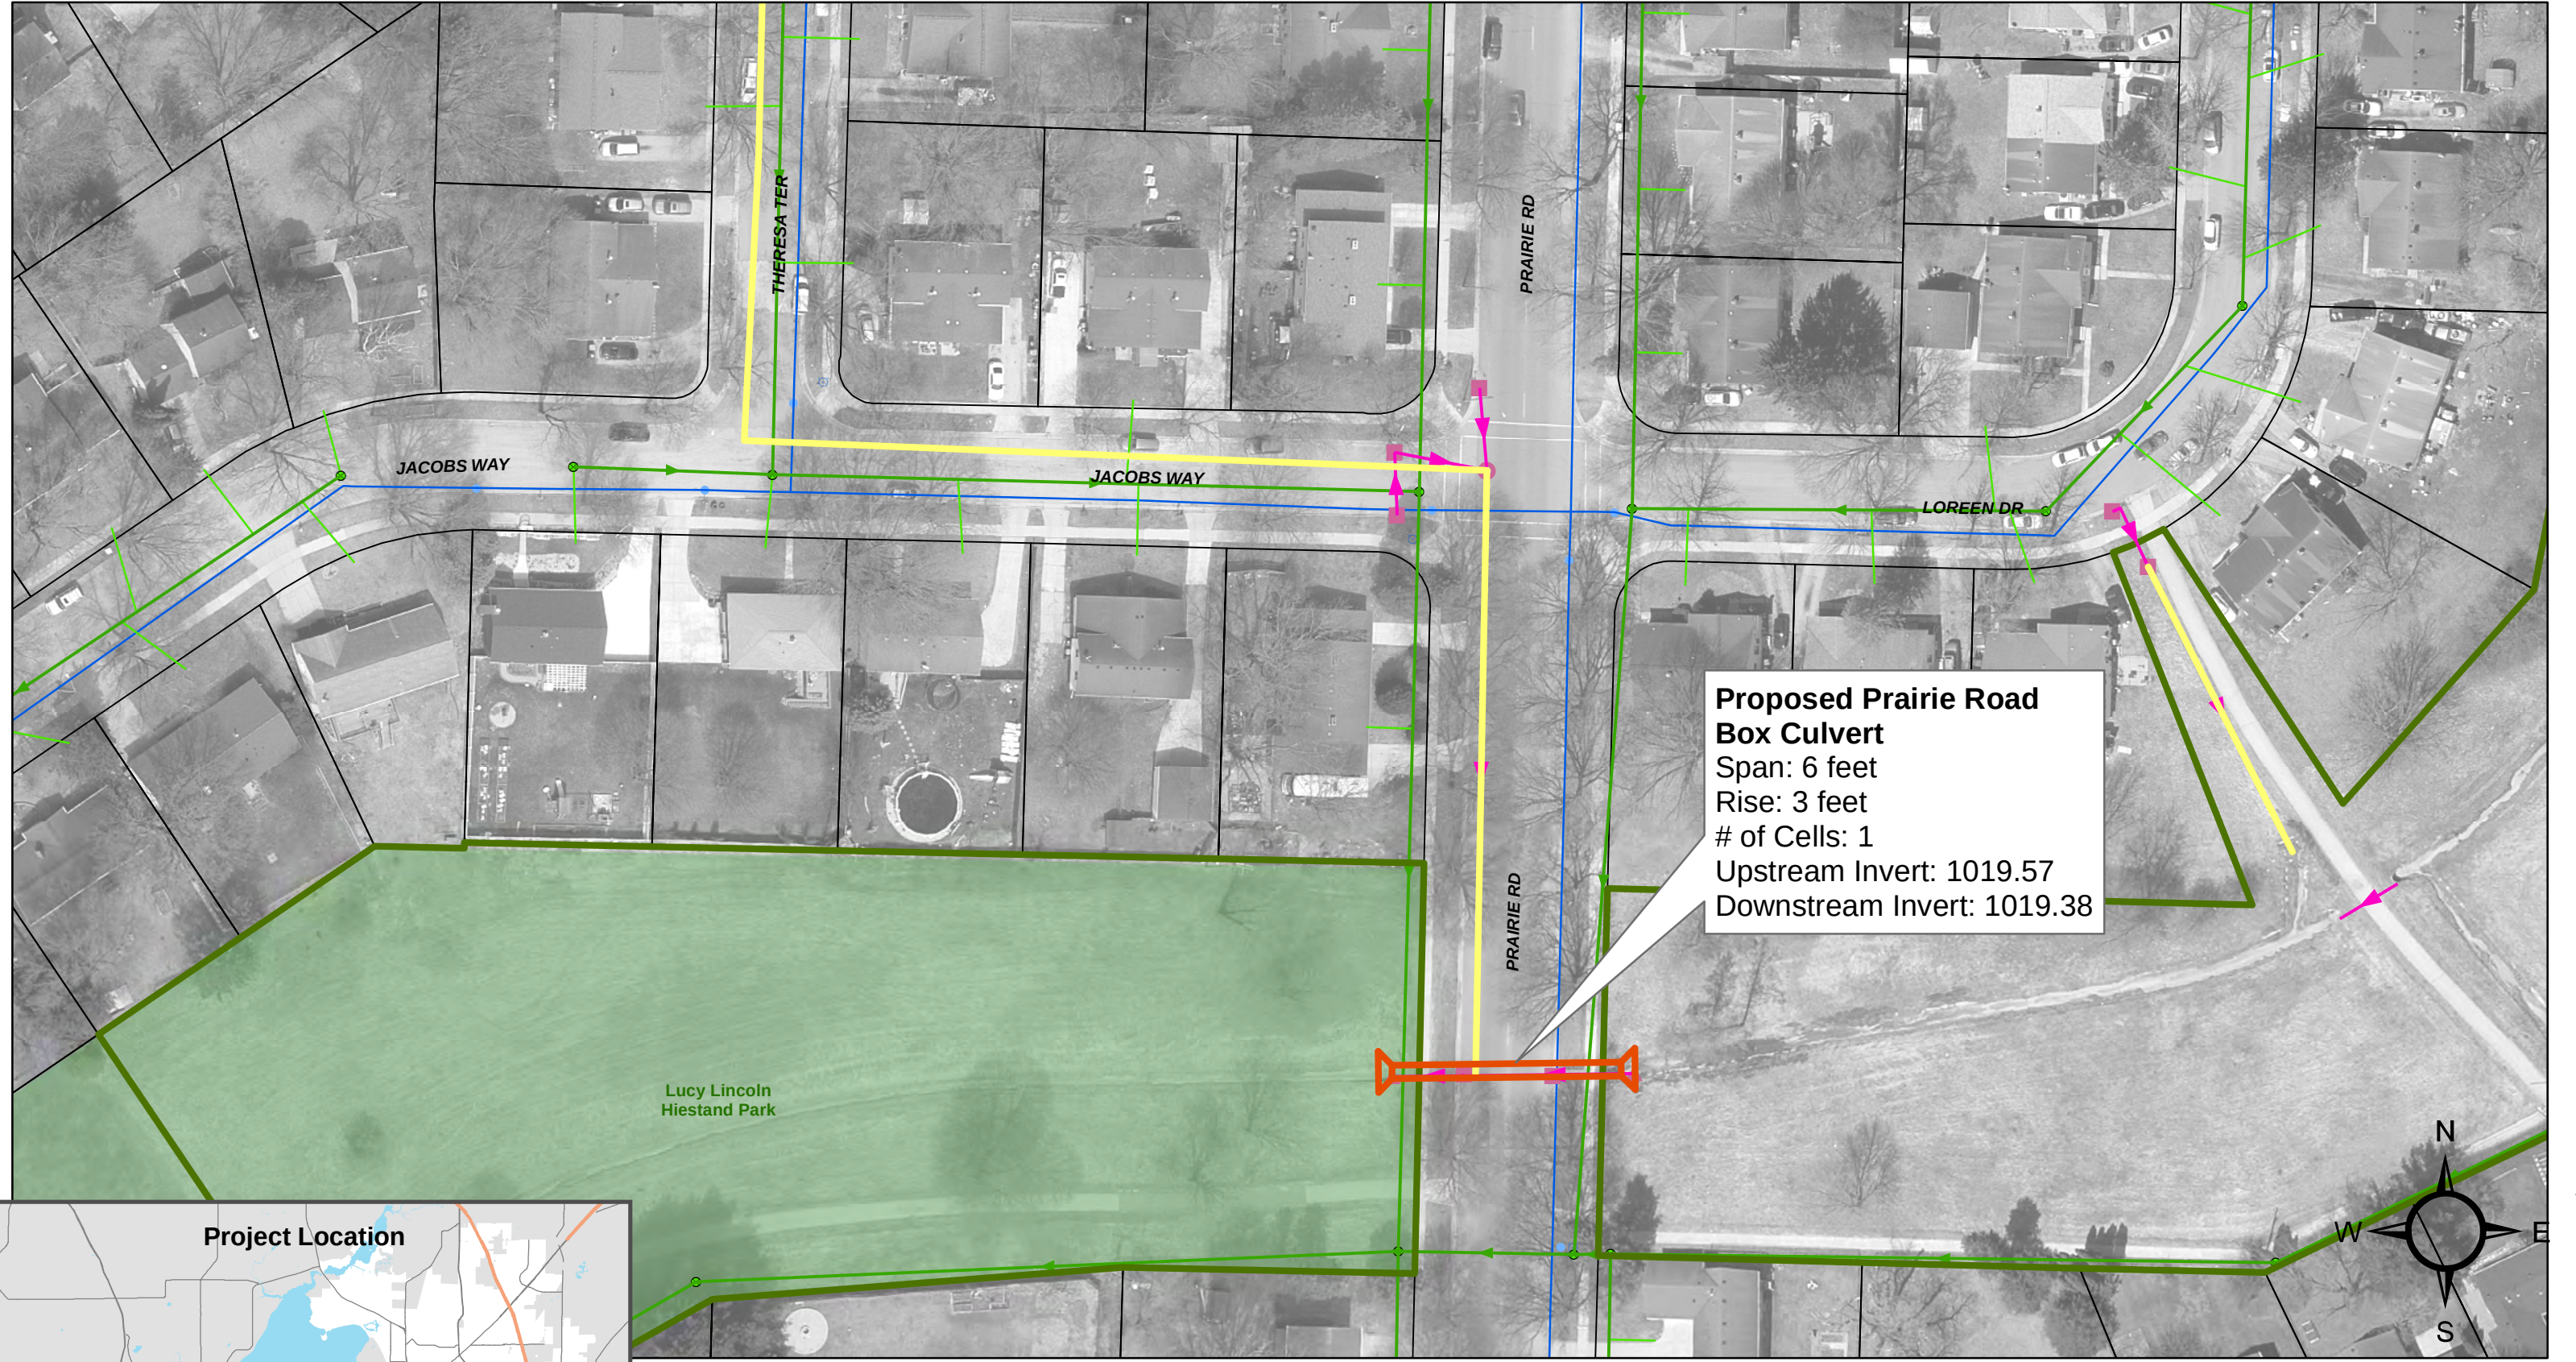
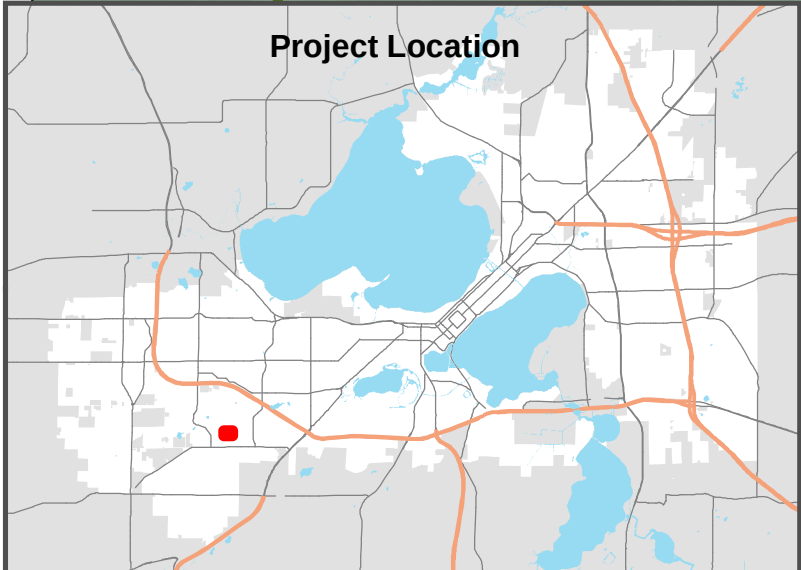
**Proposed Prairie Road  
Box Culvert**  
 Span: 6 feet  
 Rise: 3 feet  
 # of Cells: 1  
 Upstream Invert: 1019.57  
 Downstream Invert: 1019.38
