# East Badger Mill Creek Watershed Study Report

City of Madison, WI  
May 18, 2023

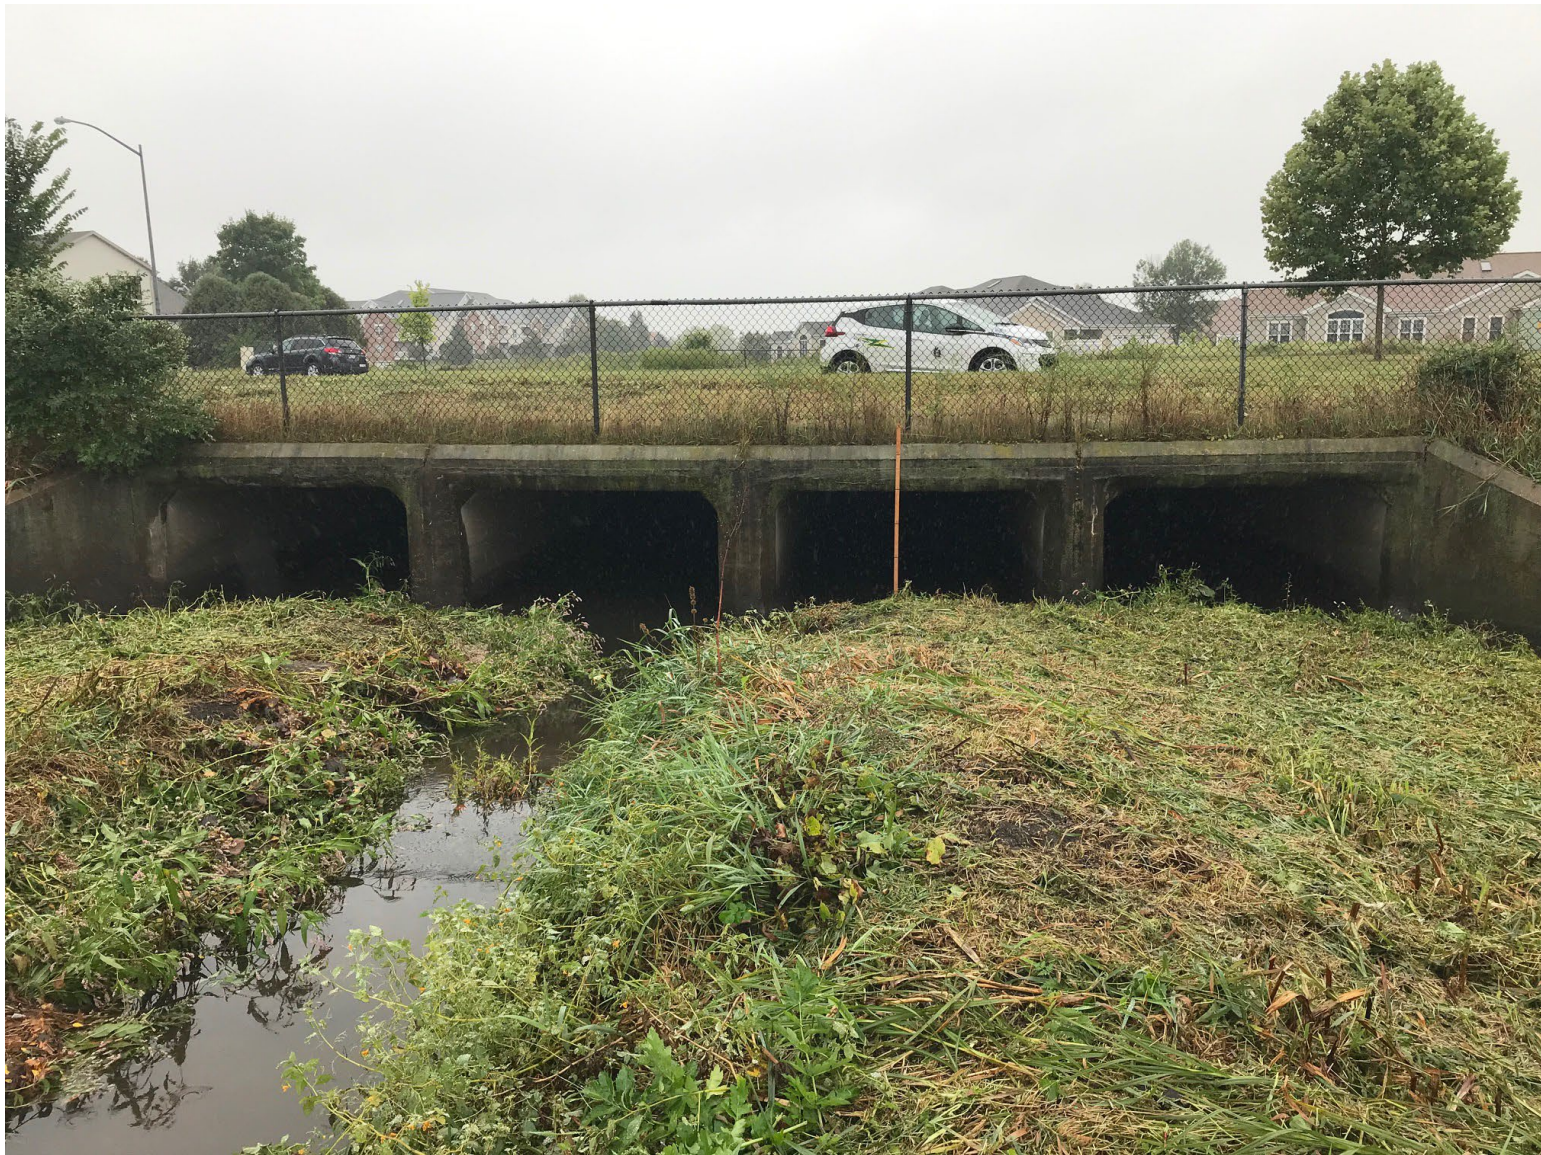
East Pass

3-8'x4' & 1-8'x5' Box Culverts with 45° Wingwalls and Beveled Top Edge (0.2 entrance loss coefficient)

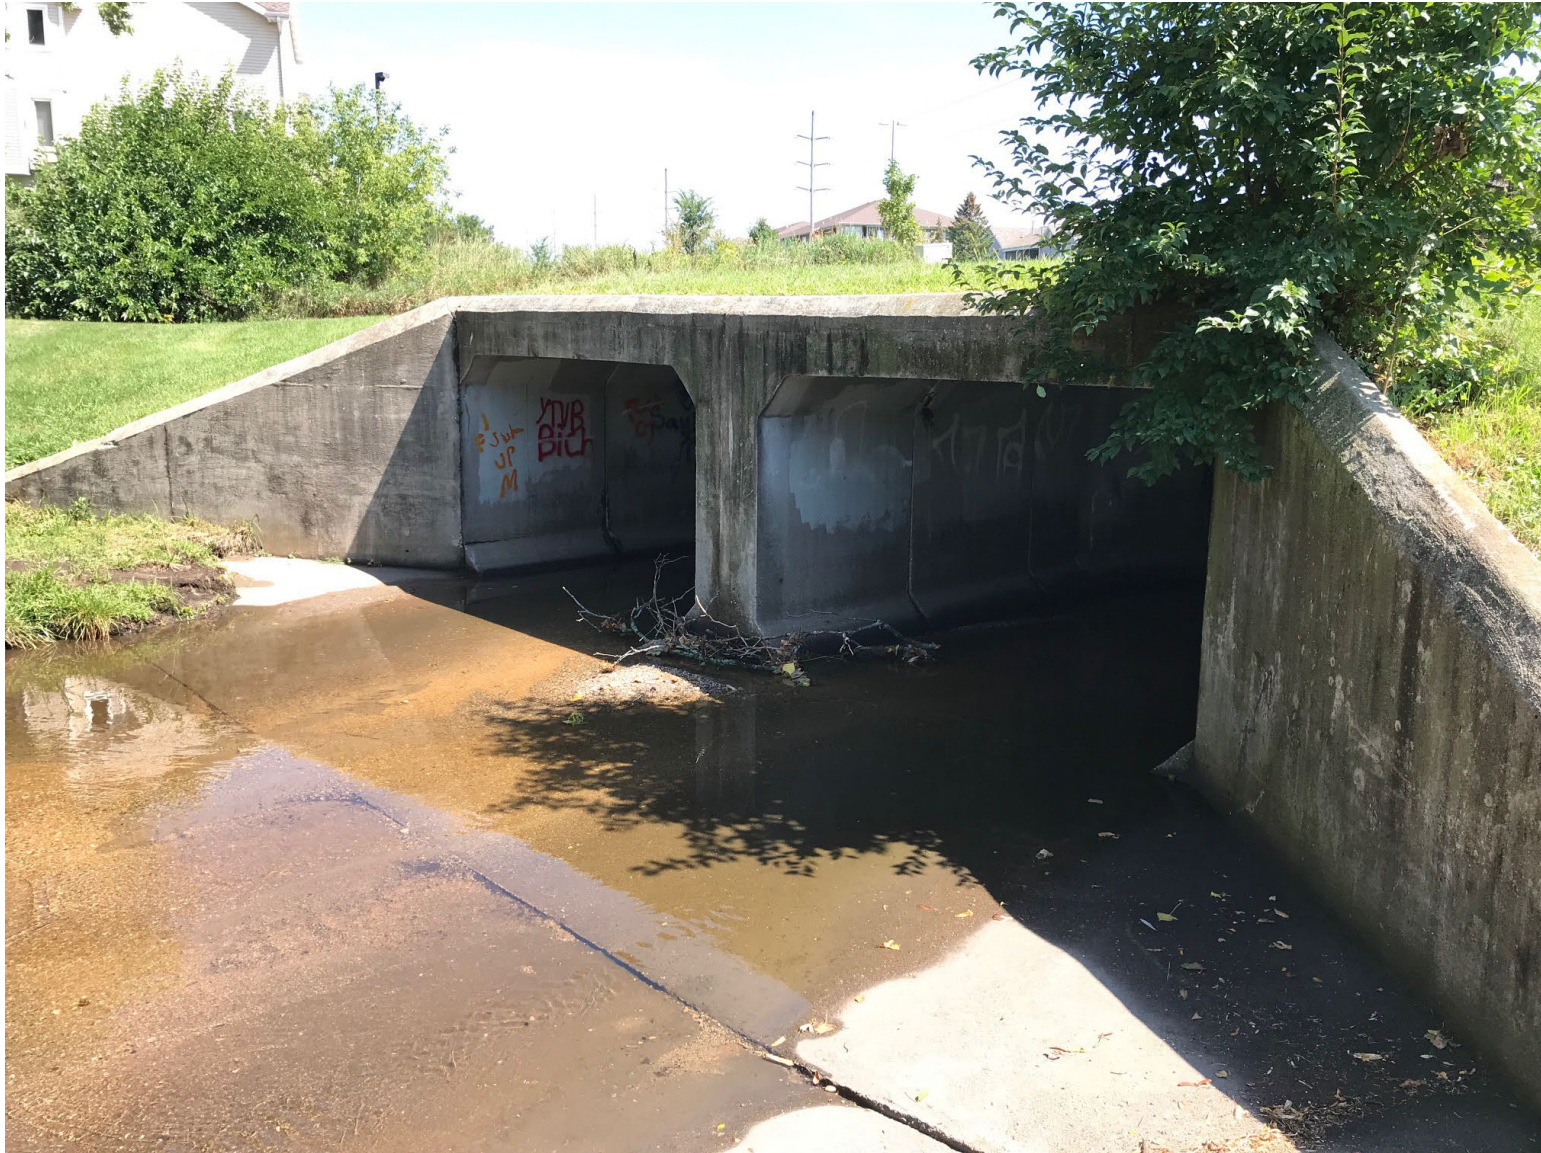
McKee Road

2-10'x6' Box Culverts with 45° Wingwalls and Square Top Edge (0.4 entrance loss coefficient)

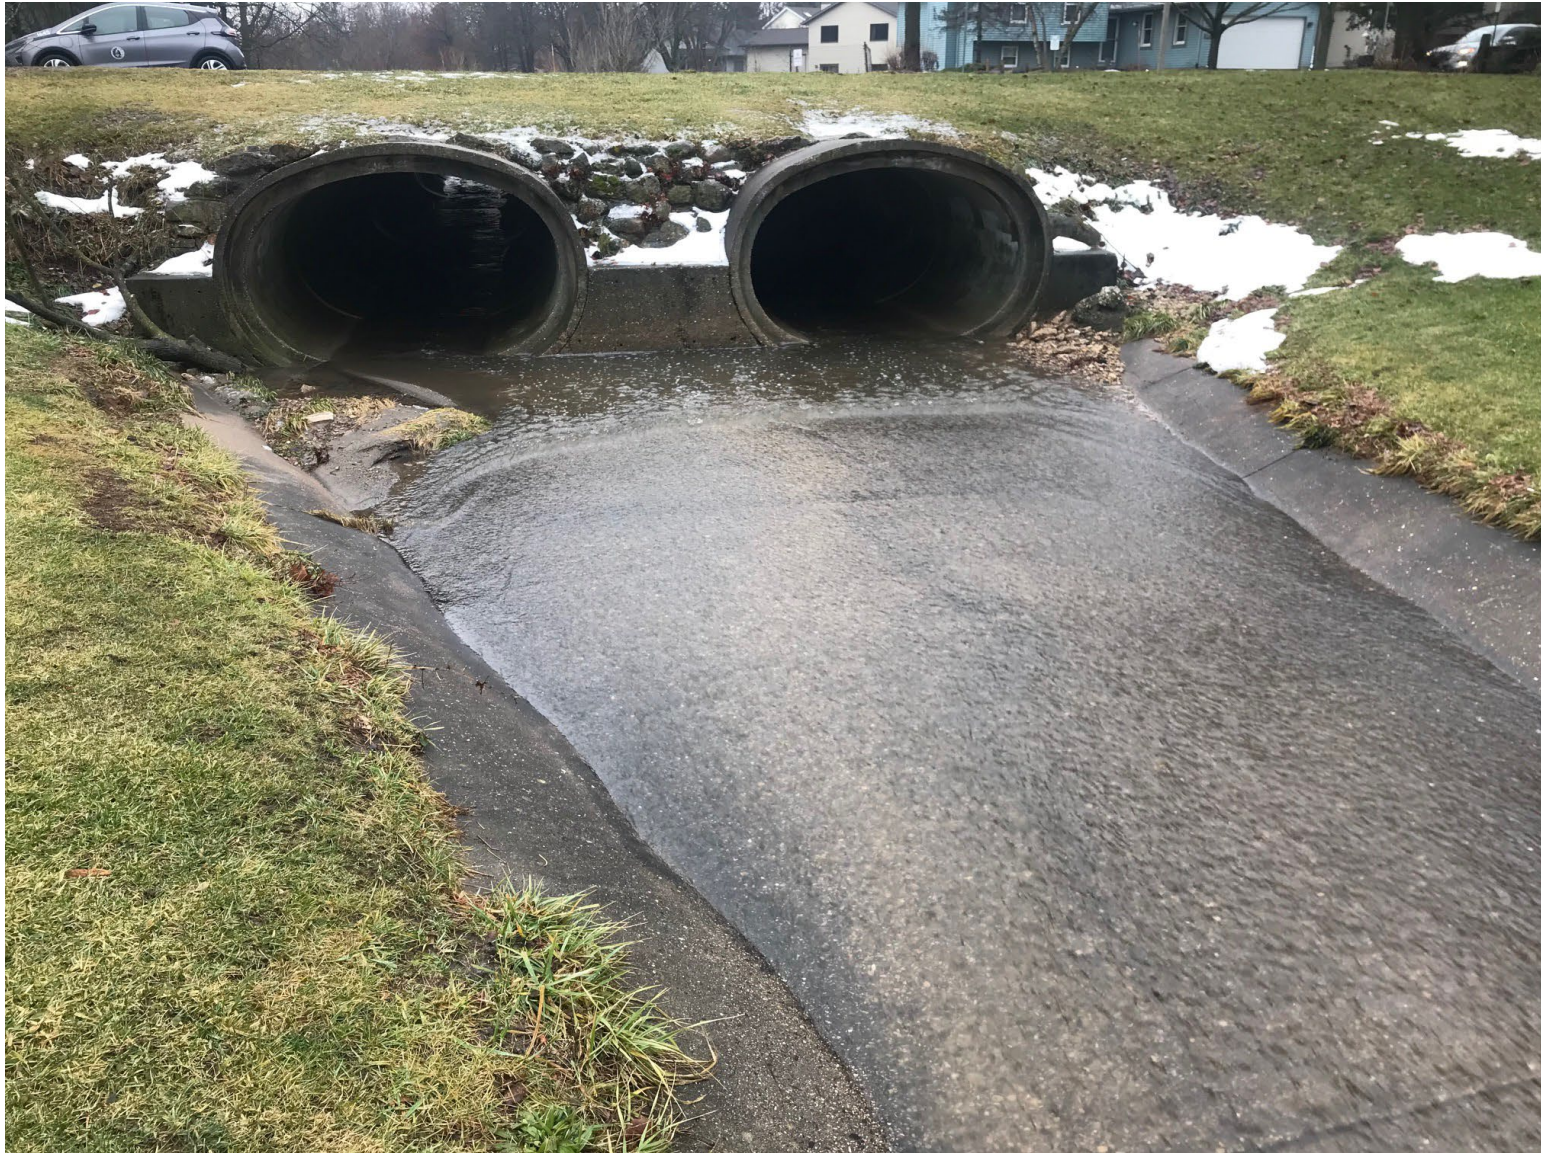
Carnwood Road  
2-63"x98" HERCP with socket ends (0.2 entrance loss coefficient)

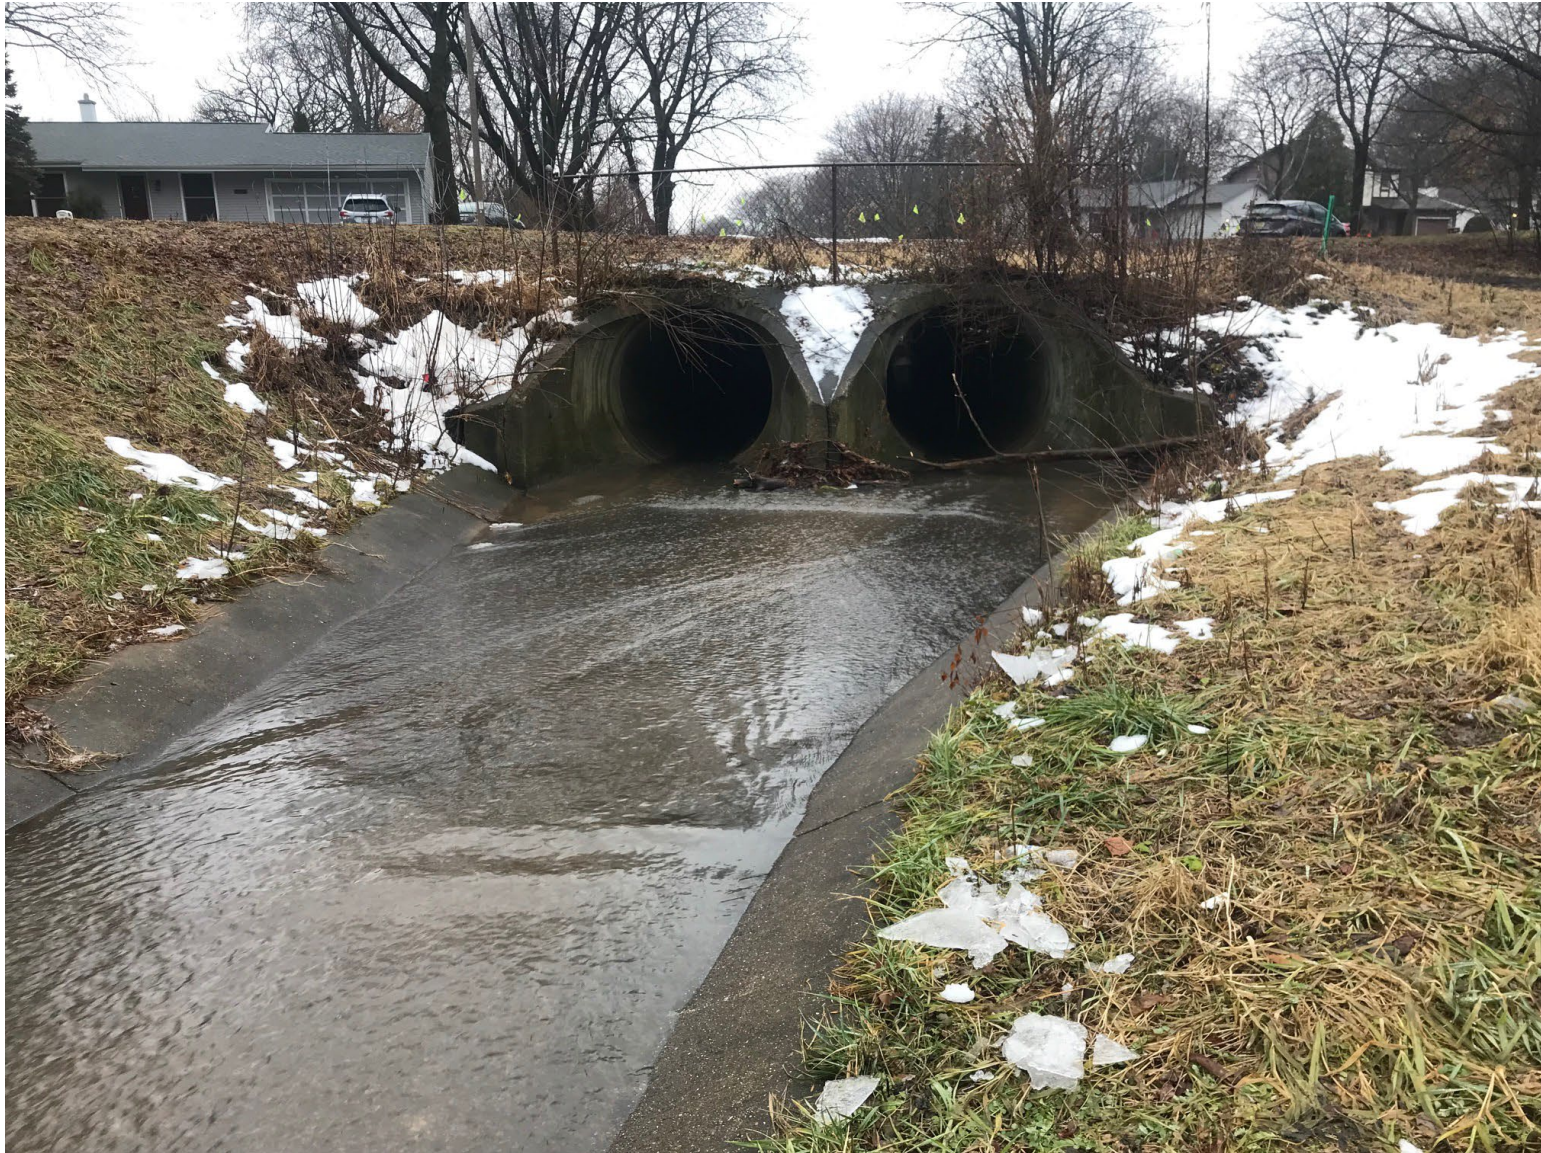
Lancaster Lane  
2-72" RCP with apron end (0.5 entrance loss coefficient)

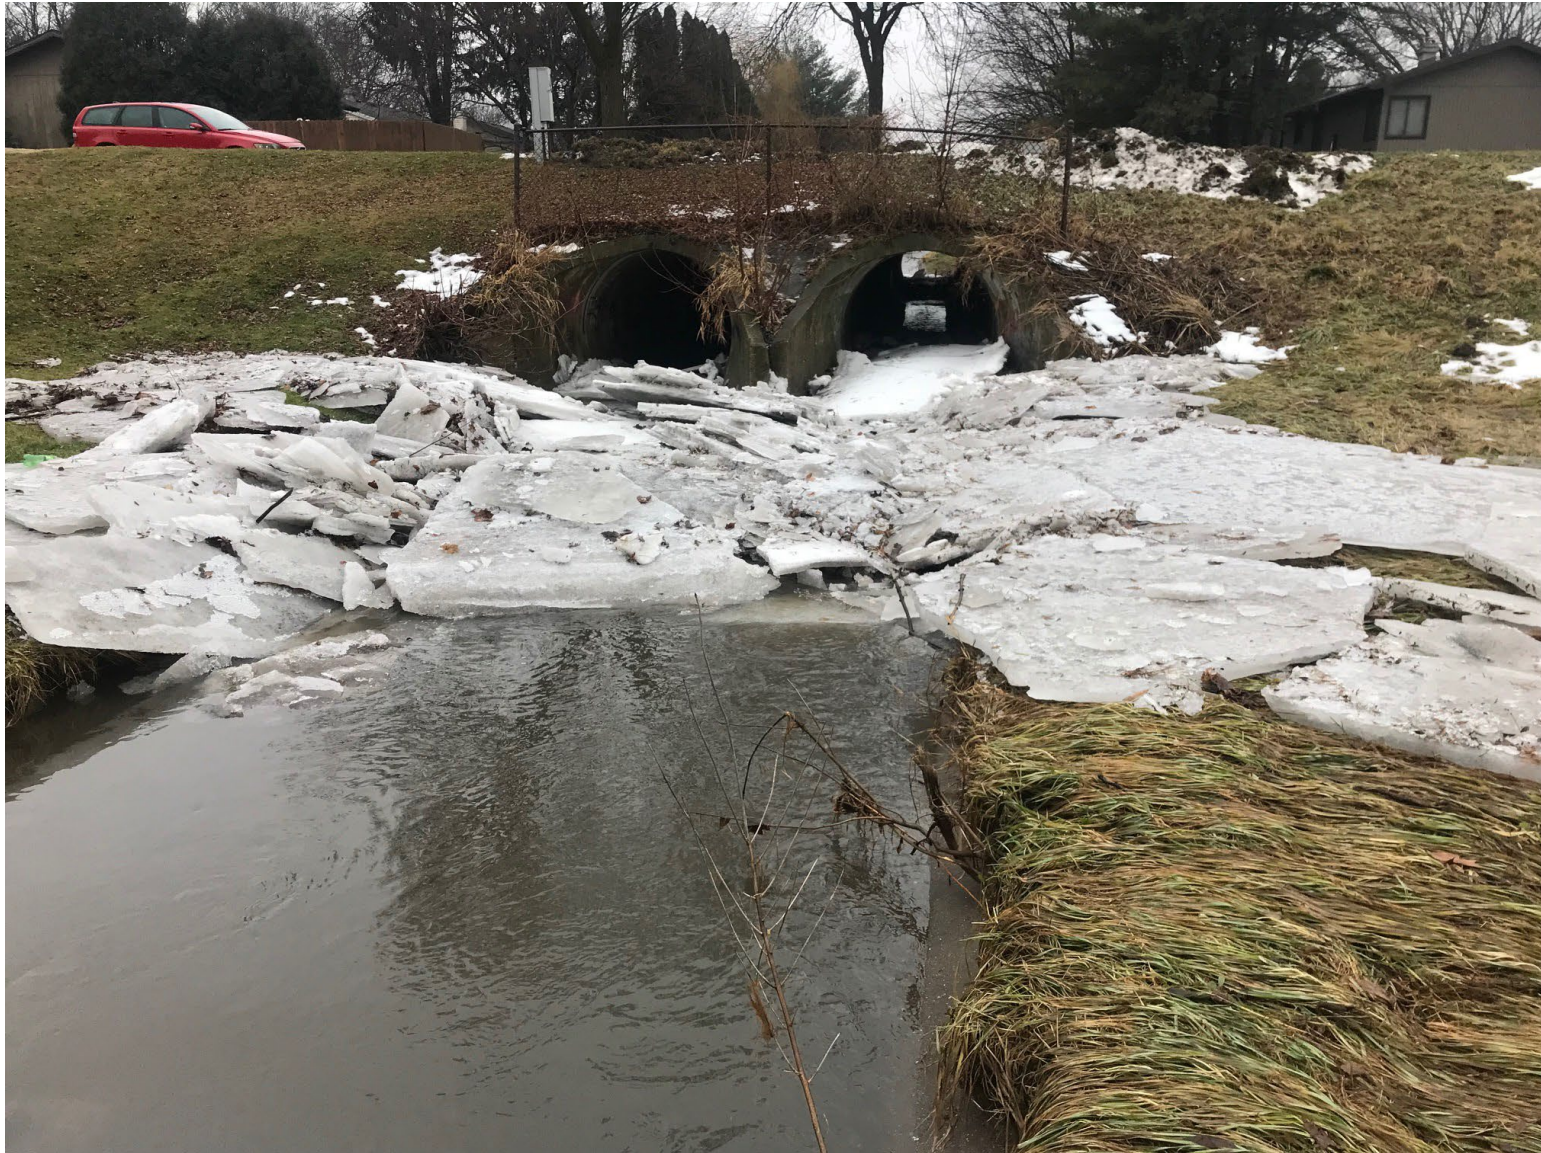
Canterbury Road  
2-72" RCP with apron end (0.5 entrance loss coefficient)

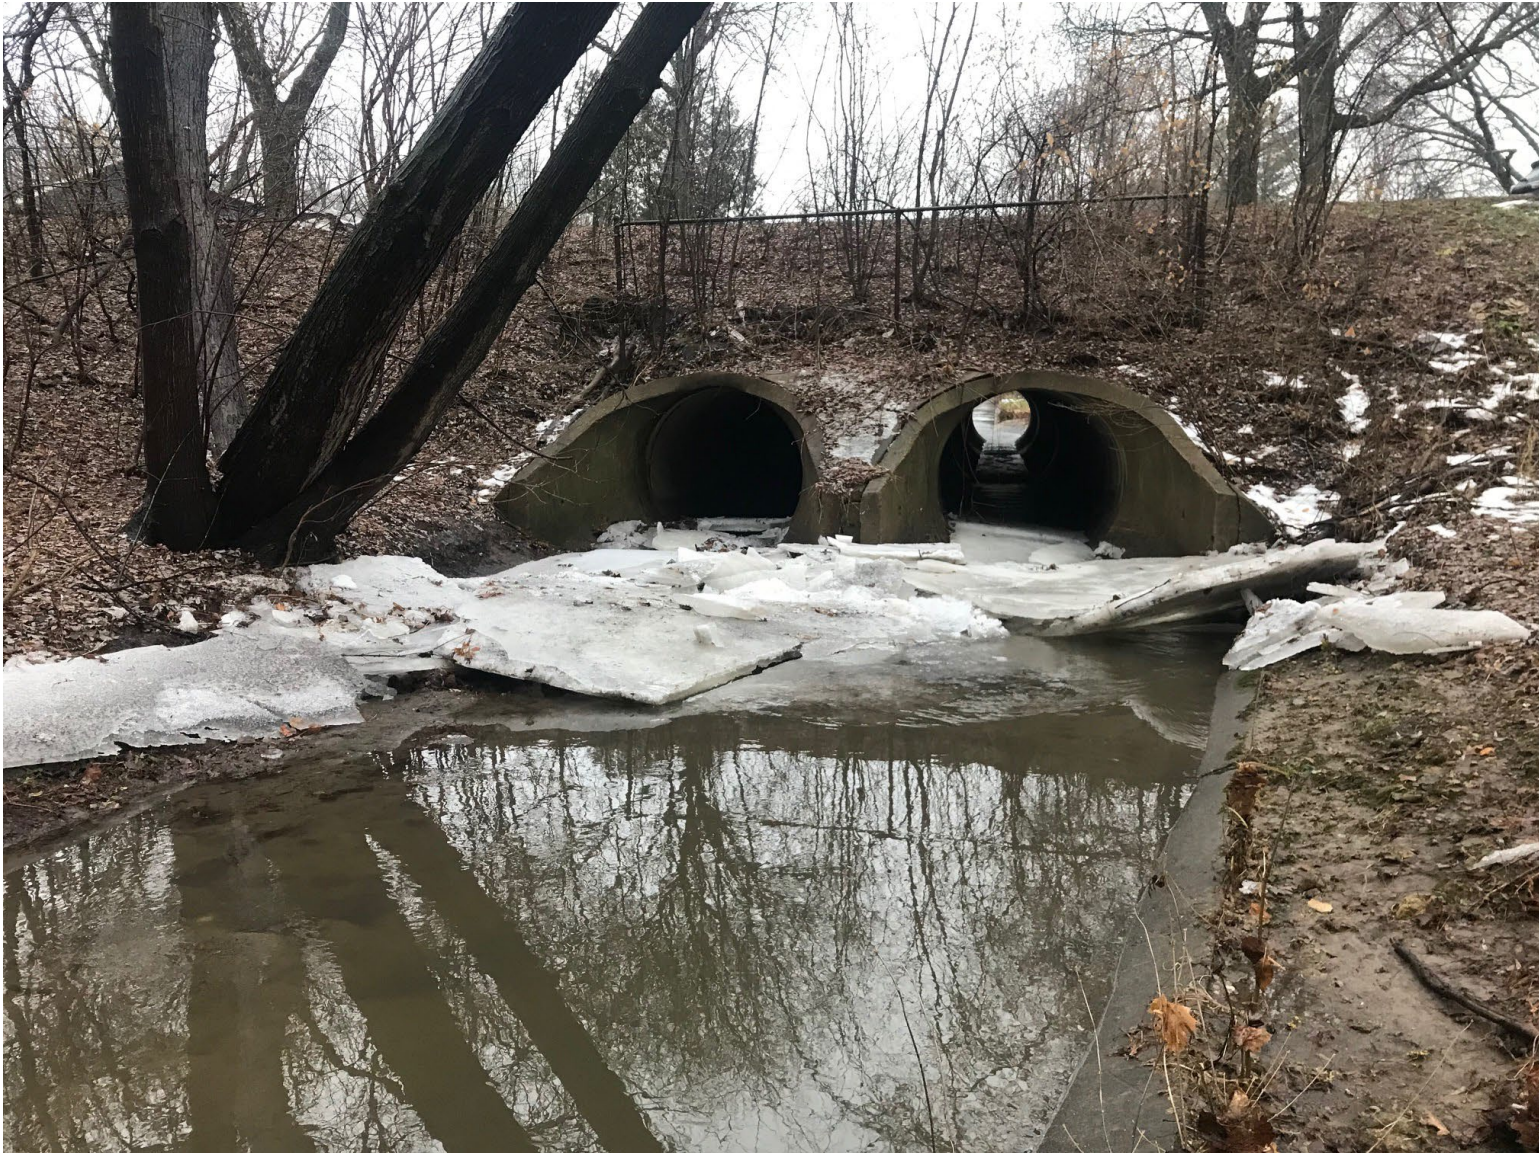
Pilgrim Road  
2-72" RCP with apron end (0.5 entrance loss coefficient)

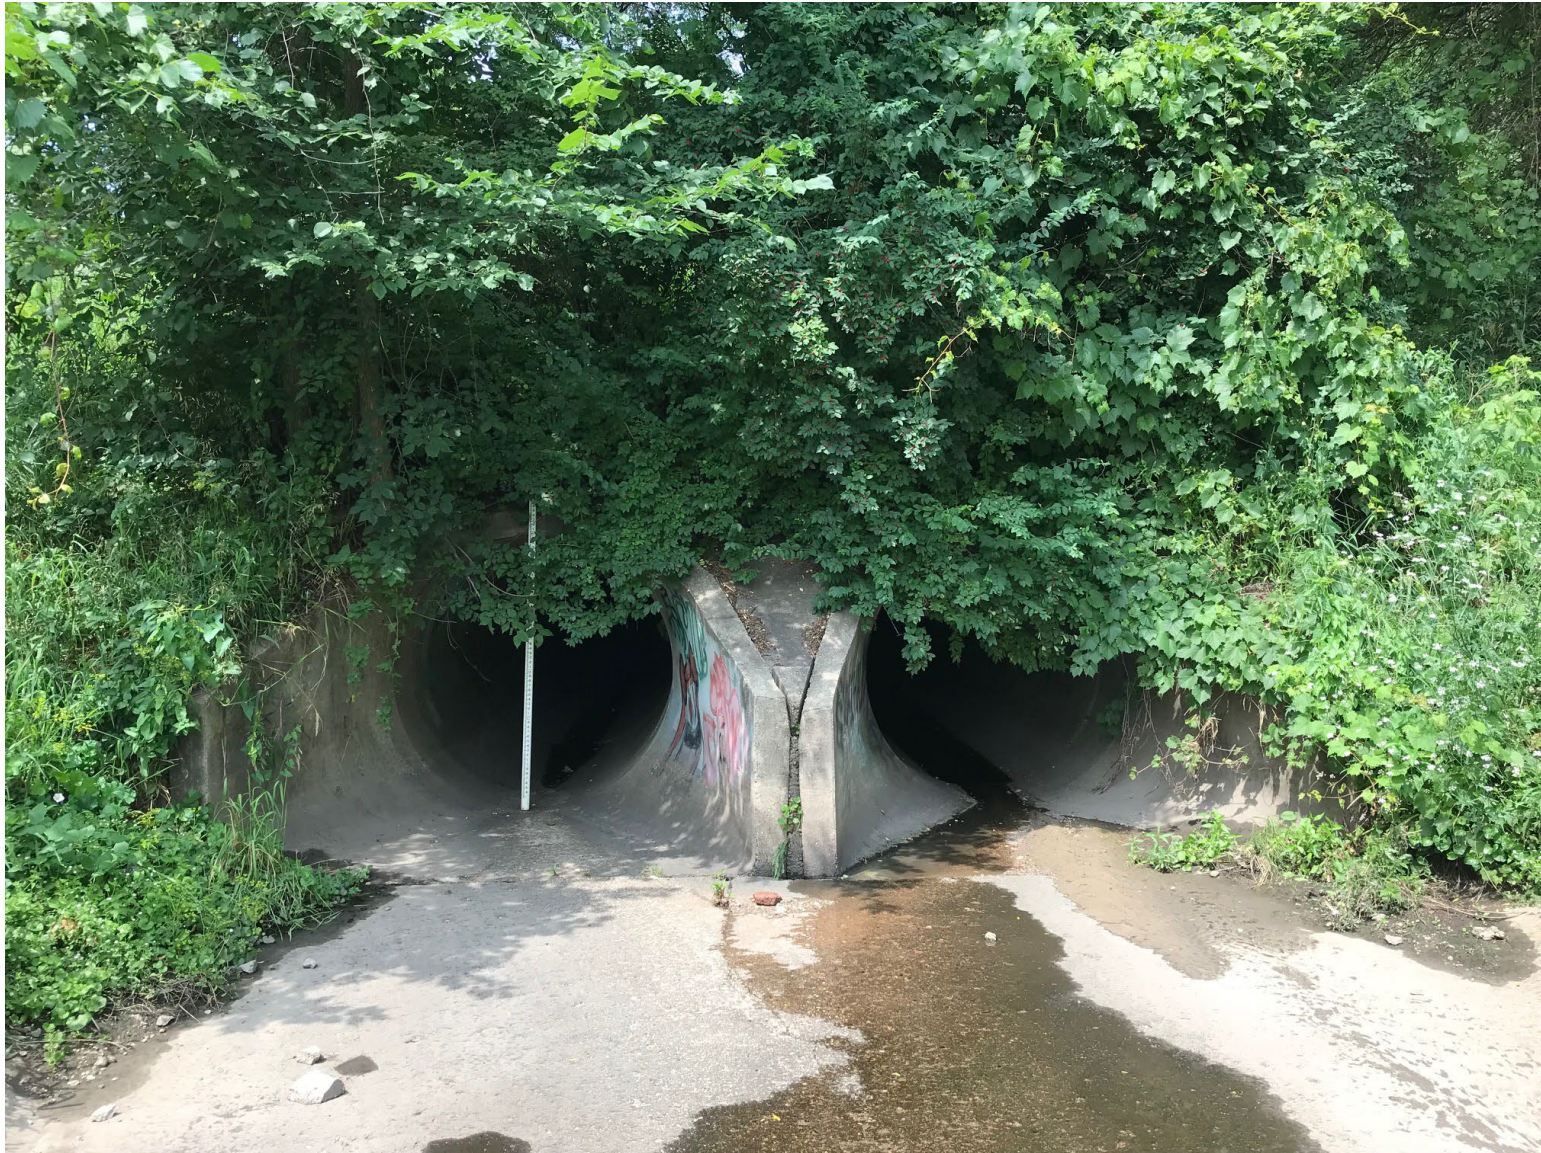
McKenna Boulevard  
2-72" RCP with apron end (0.5 entrance loss coefficient)

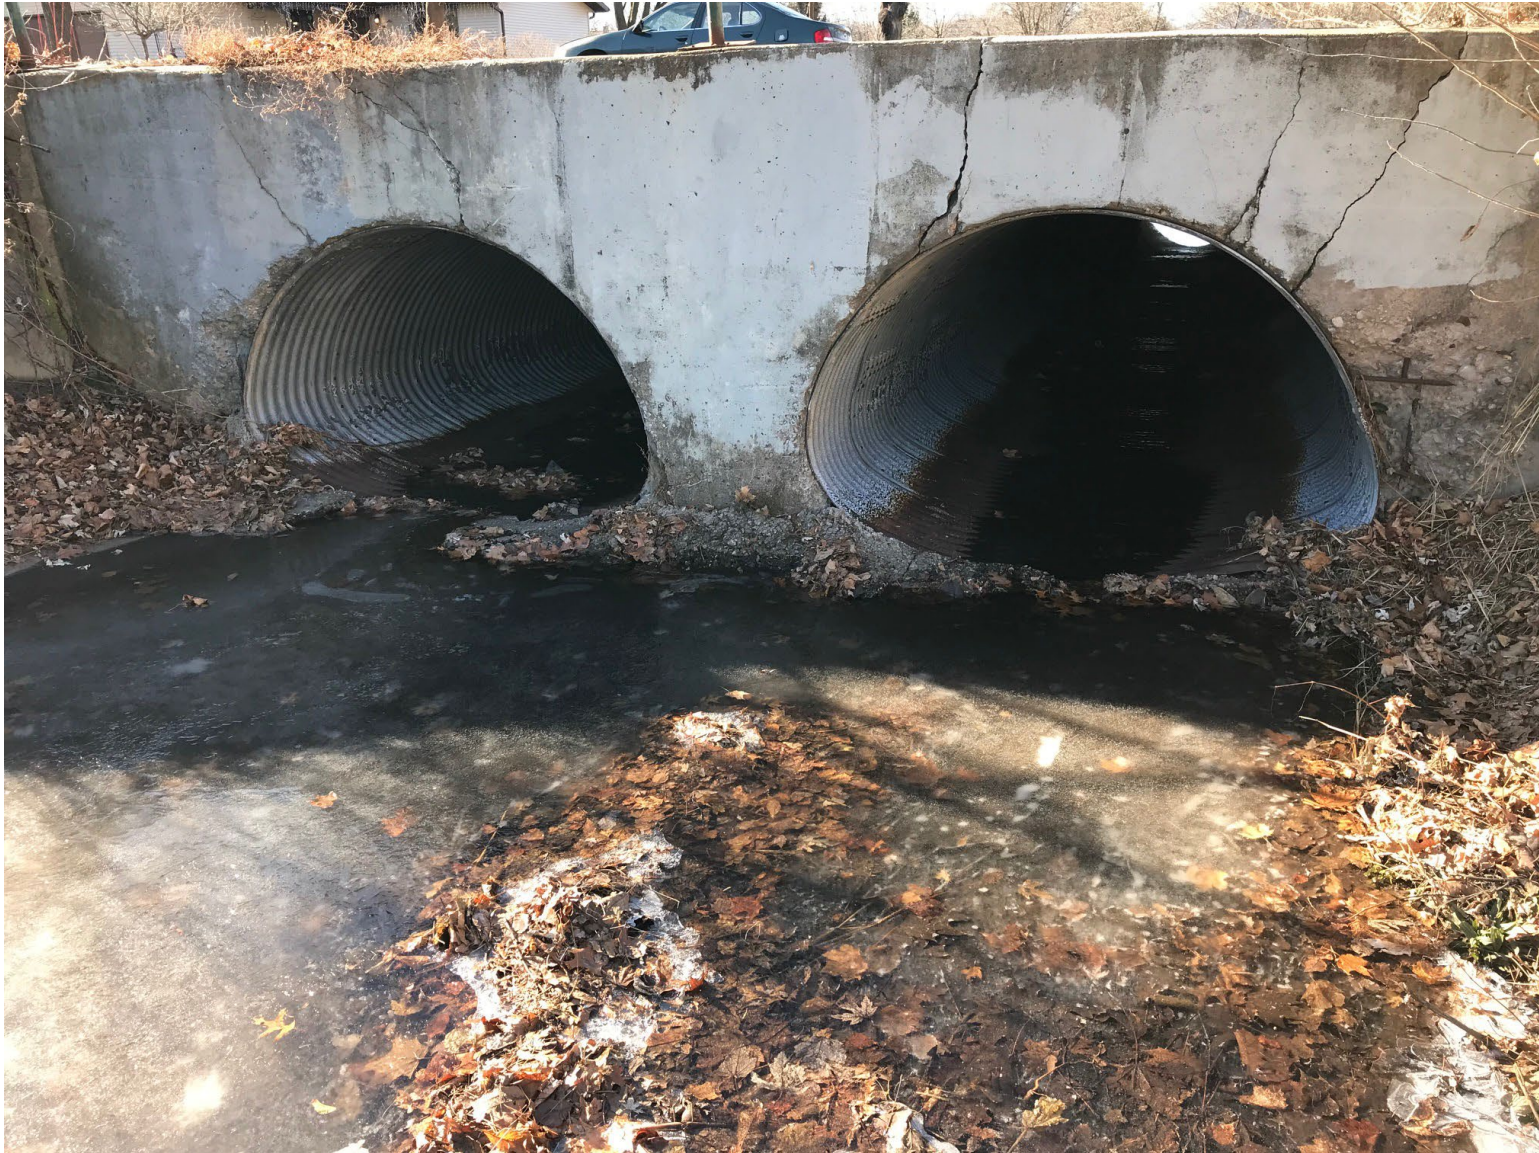
Westbrook Lane  
2-47"x71" CMPA with vertical headwall and square edge (0.5 entrance loss coefficient)

\*included in City records as 48"x76" CMPA; after existing conditions model was finalized, field measurement confirmed as 47"x71" CMPA

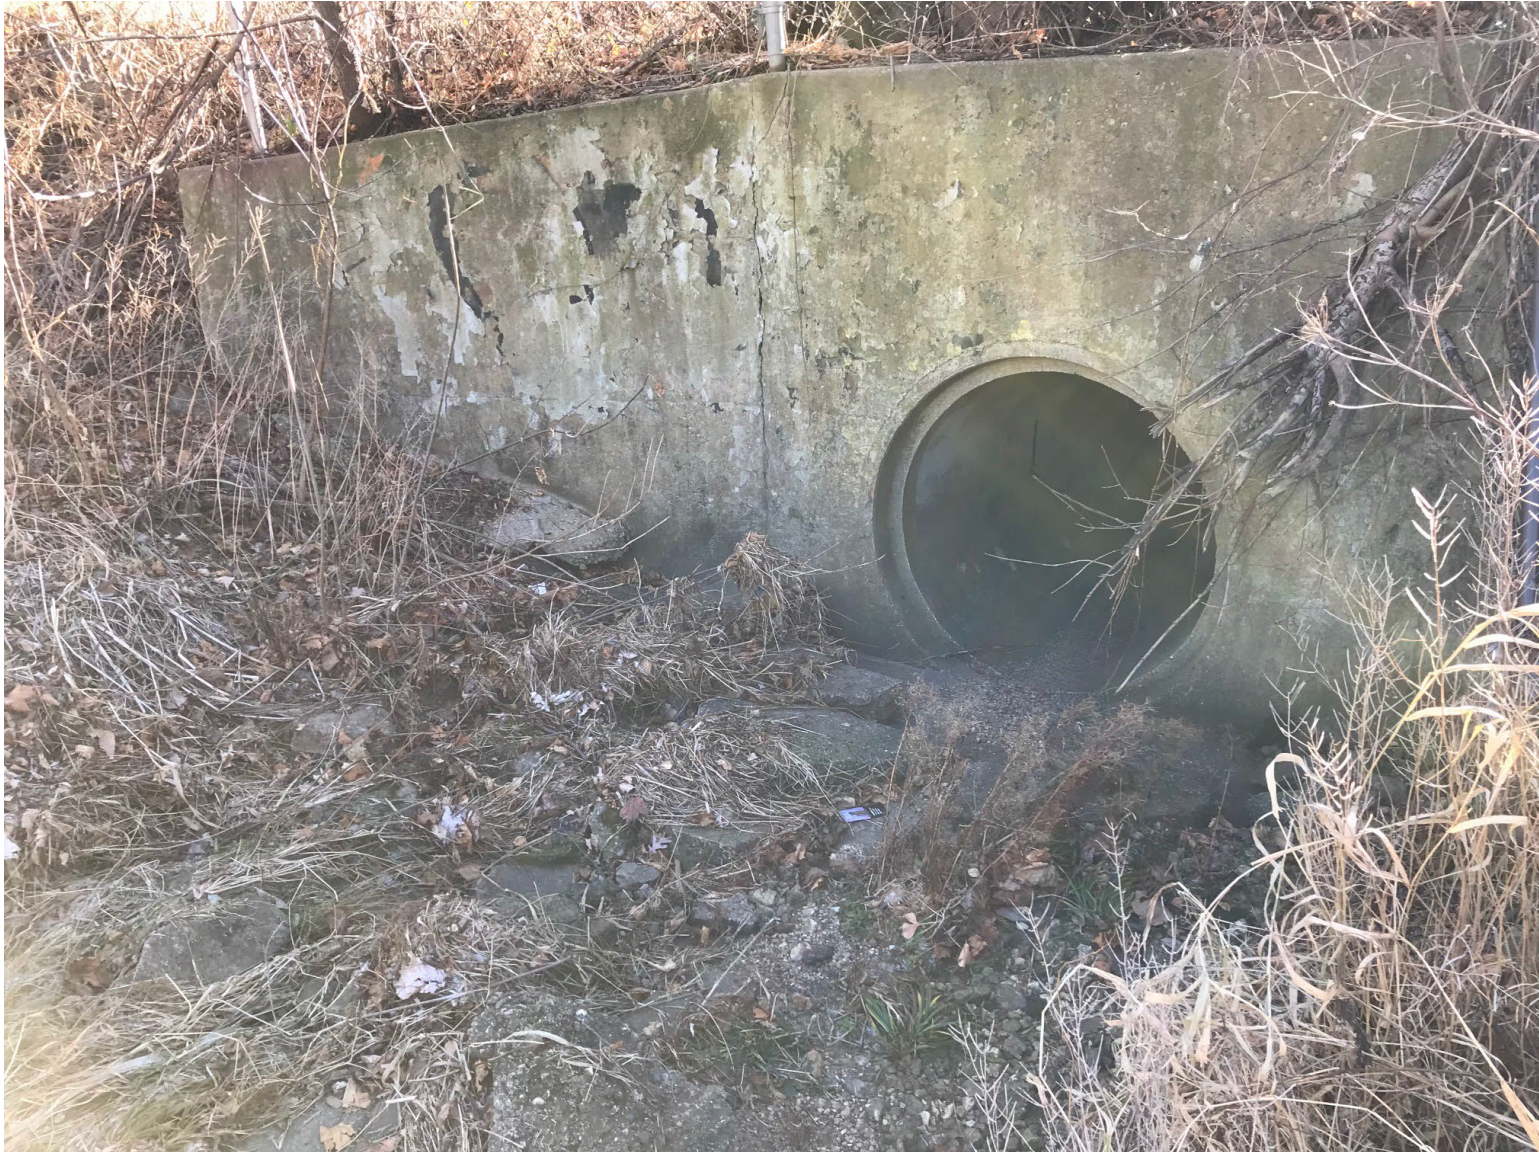
Raymond Road  
48" RCP with vertical headwall and socket end (0.2 entrance loss coefficient)

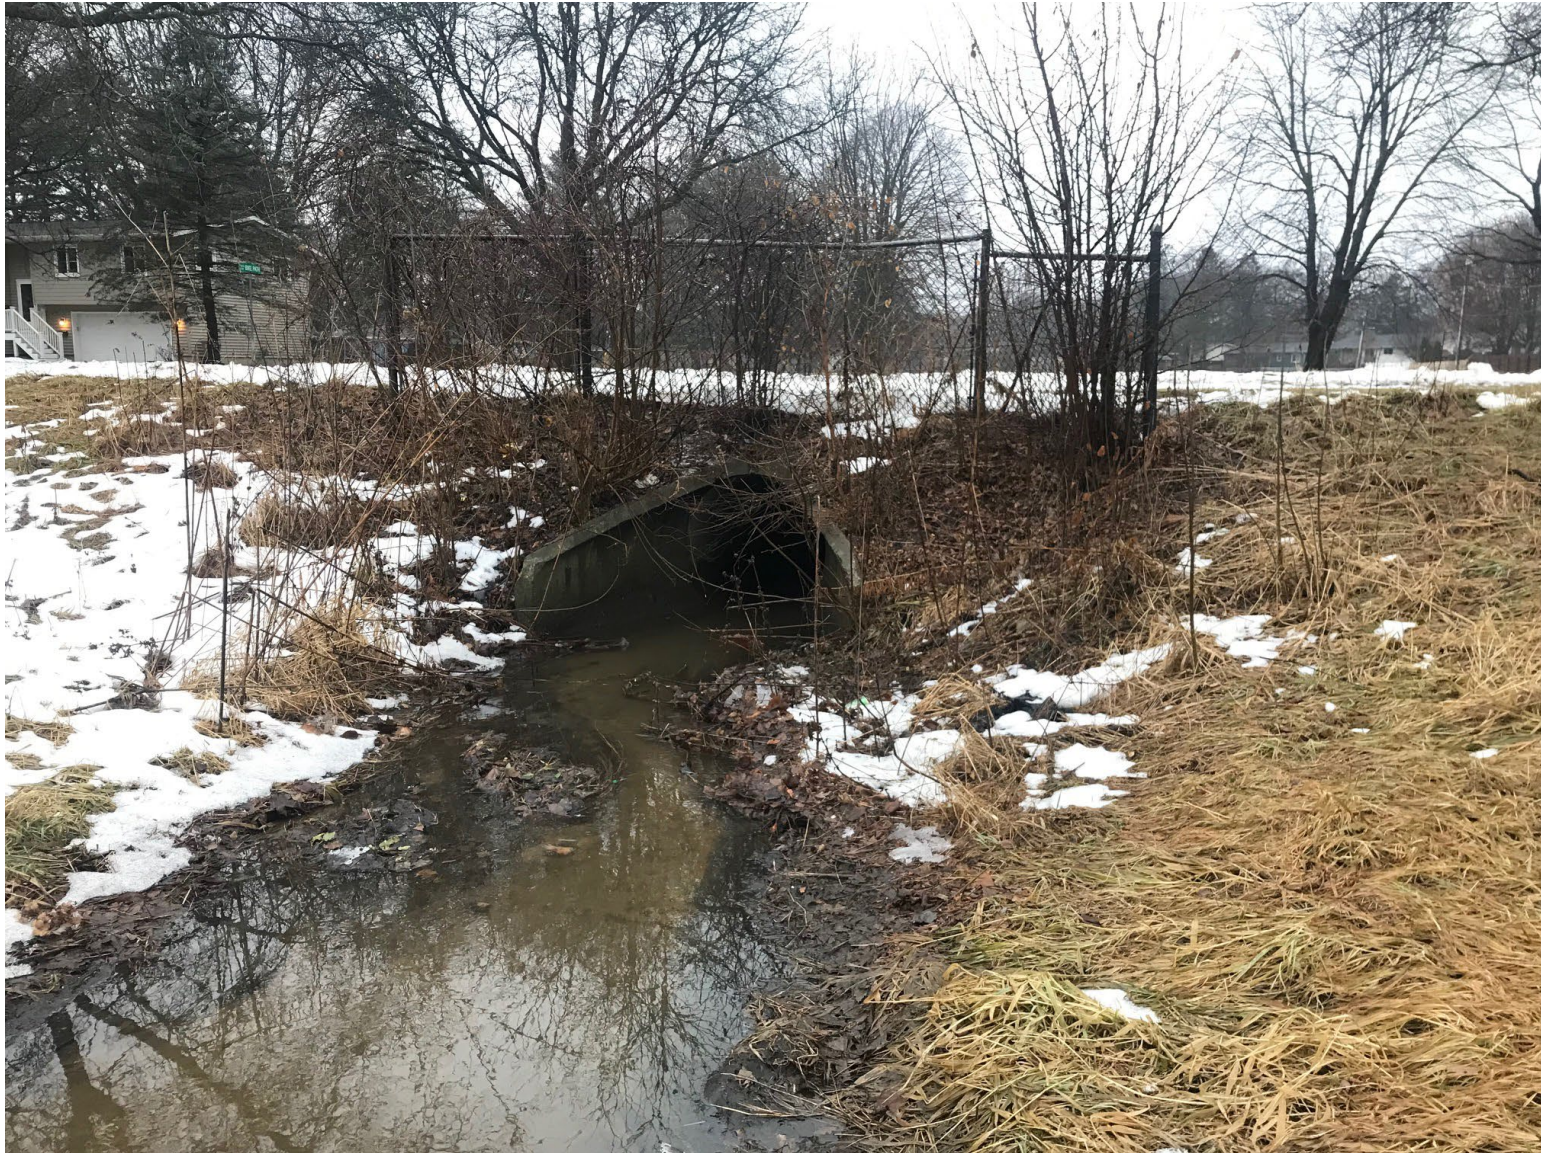
Prairie Road  
42" RCP with apron end (0.5 entrance loss coefficient)

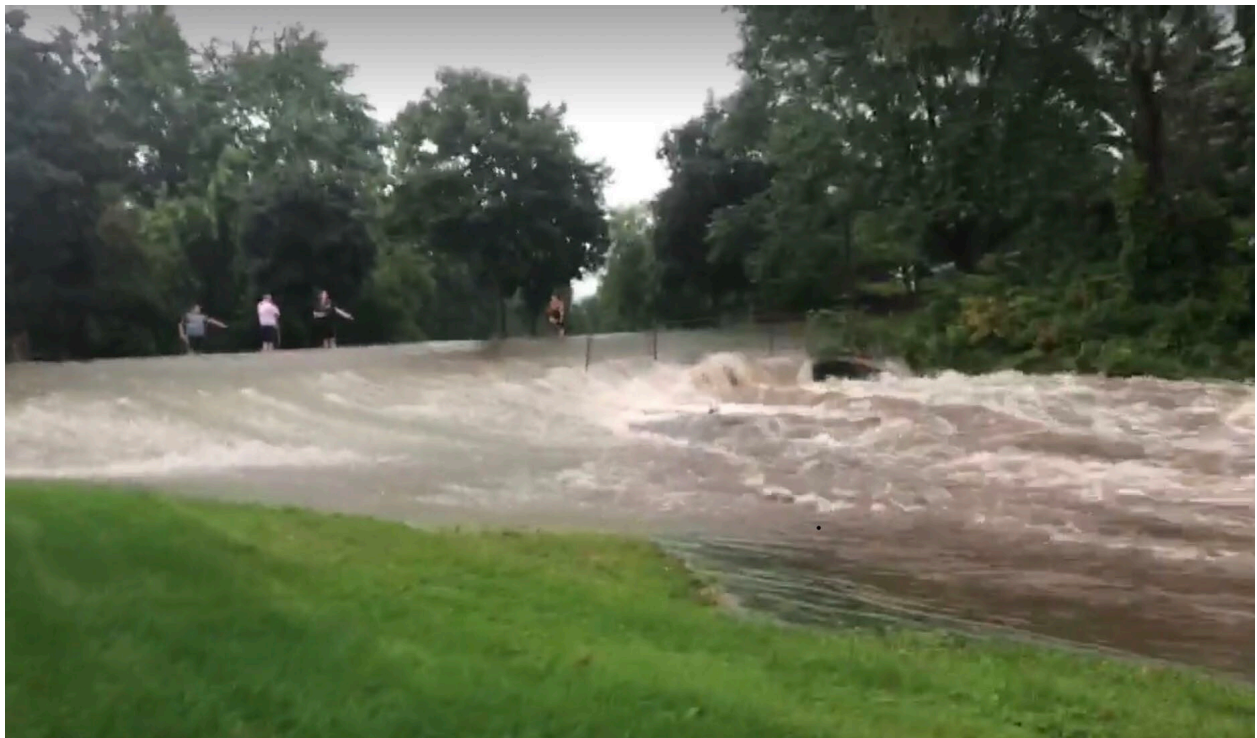
Looking NE at Lancaster Lane and culvert outlet ends – August 20, 2018
